FIRE SAFETY OF THE RAILWAY SYSTEMS

W.K. Chow

Department of Building Services Engineering, The Hong Kong Polytechnic University, Hong Kong, China

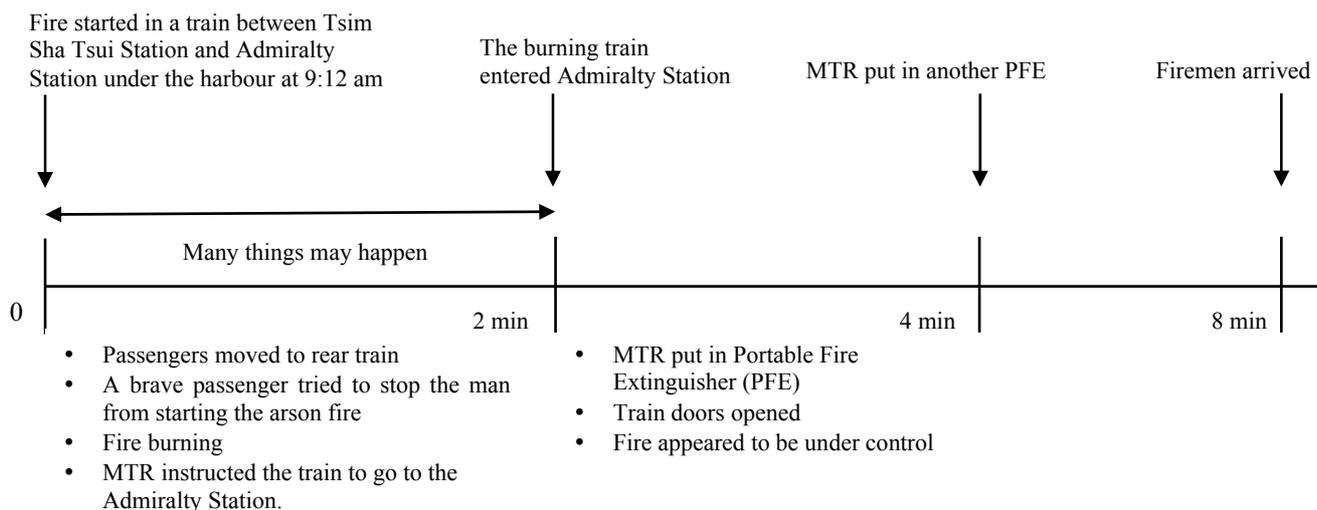
Fig. 1: Time line of the events in the MTR train fire

An arson fire happened in an MTR train vehicle [1] while travelling under the harbour at 9:12 am on 5 January, 2004. As reported in that LegCo paper [6], a time line [10] of the events can be drawn as in Fig. 1 to describe the incident. The fire lasted for at least 2 minutes, with something still burning up to 4 minutes. The time line [9,10] for the

The MTR arson fire did not grow big [1] as in the South Korean train fire [2], though the arson fire started in a similar way from four bottles of liquid fuels, which appeared to have similar combustion behaviour. Anyway, the train was instructed to move into the station 2 minutes later. Doors were opened and passengers were evacuated. The fire appeared to be under control within 4 minutes. Only 16 passengers and 1 staff were injured.

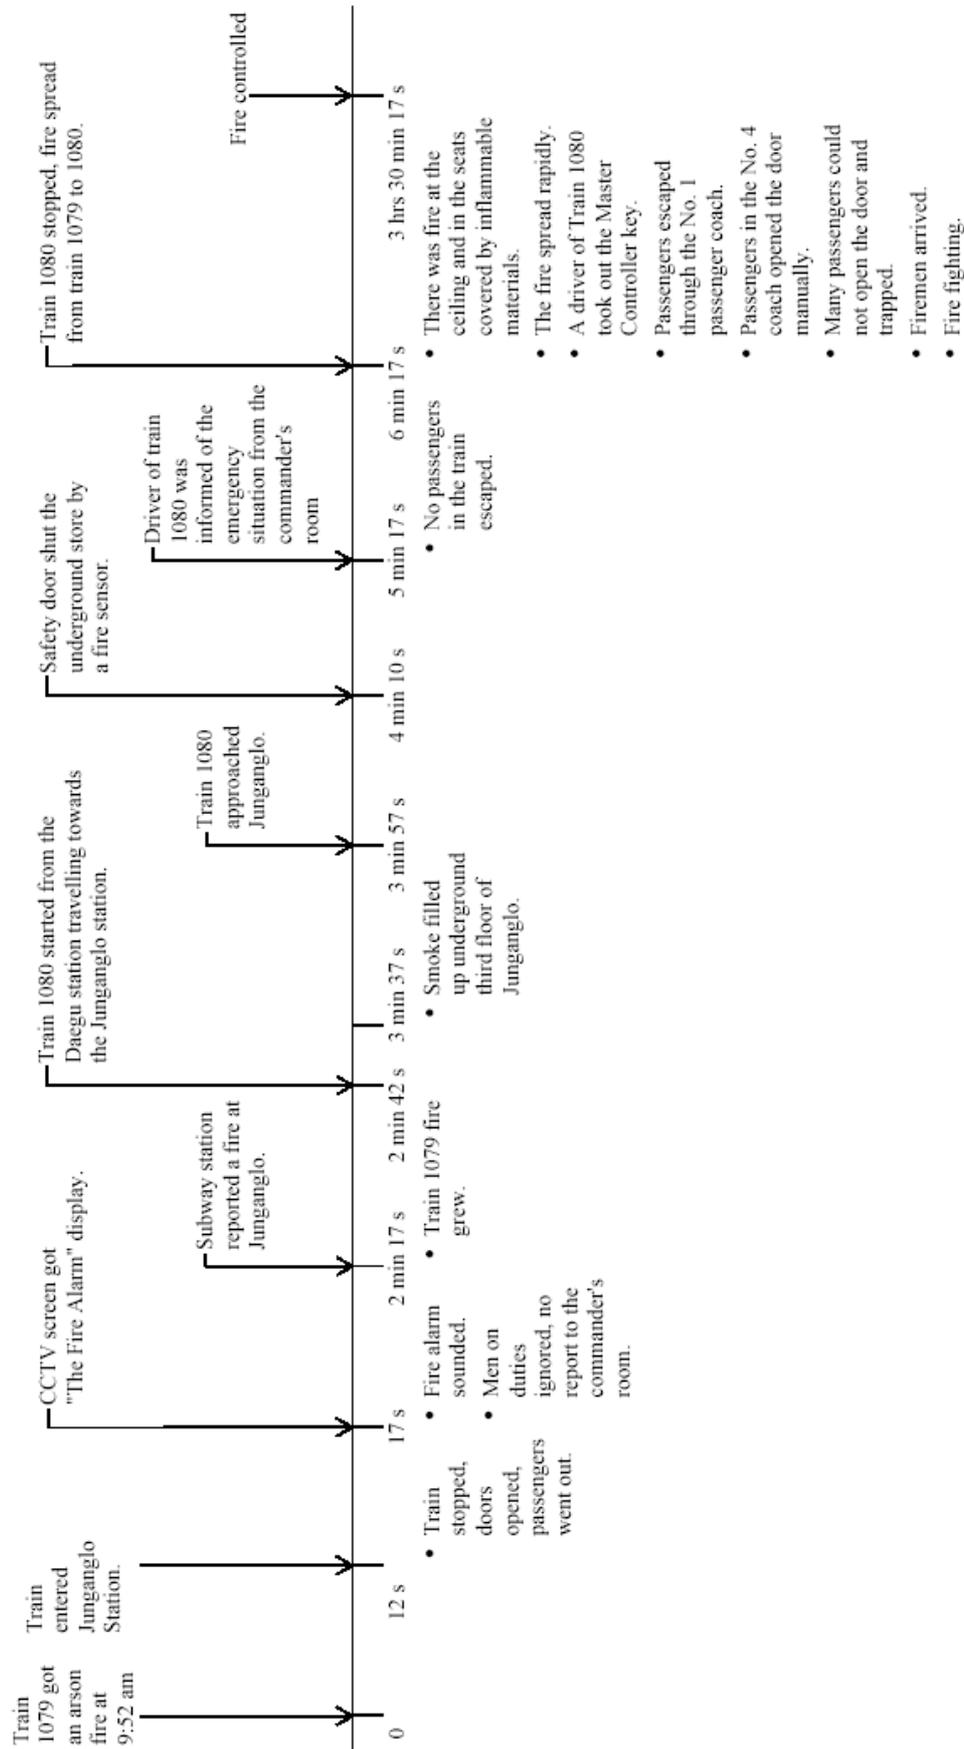
Fig. 2: Arson fire on 18 February, 2003, Daegu, South Korea

Daegu train fire in South Korea occurred on 18, February 2003 is also drawn in Fig. 2 based on the reports appeared in the recent literature [e.g. 11-13]. This indicated that 5 minutes would lead to a disaster [11-15].

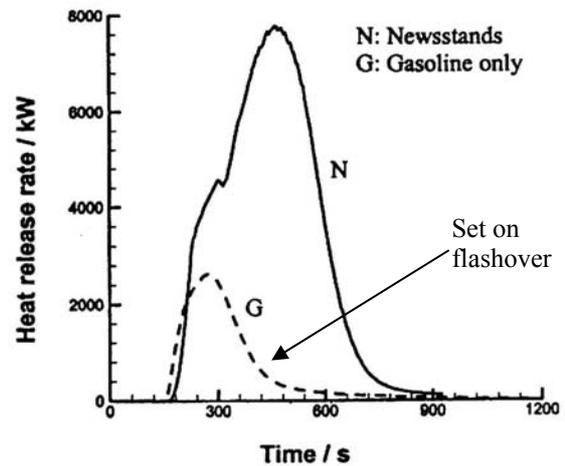
Fig. 3: Heat release rate

Both bench-scale tests on materials with a cone calorimeter [34,35] and preliminary full-scale tests [36,37] for a retail shop under flashover indicated that the heat release rate of burning the materials will be very different under flashover condition. Testing the materials under small accidental fires will not give their behaviour under real-fire situations.

The heat release rate in burning a retail shop [37] under a flashover fire with limited openings can go up to 8 MW. Therefore, the possible heat release rate of a train upon burning should be measured under a flashover fire. In fact, the estimated fire size for the Korean railway fire was at least 20 MW as reported in the fire investigation [11-15]. Testing the materials under small accidental fires [e.g. 40,41] might not be sufficient to assess the behaviour of materials under a flashover fire [37].
