## **REPORT ON A RECENT FIRE IN A NEW CURTAIN-WALLED BUILDING IN DOWNTOWN DALIAN**

**W.K. Chow and S.S. Han**

Research Centre for Fire Engineering, Department of Building Services Engineering  
Area of Strength: Fire Safety Engineering, The Hong Kong Polytechnic University, Hong Kong, China

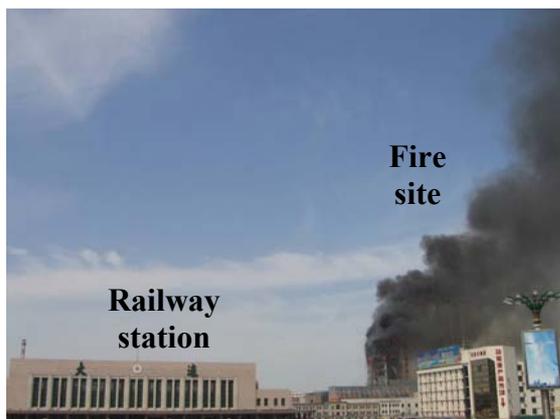
(a) Building next to a Railway station

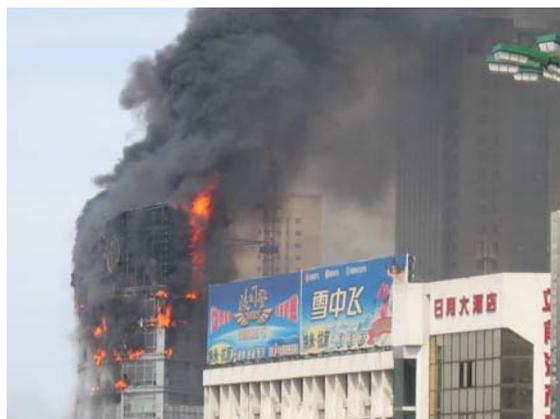
(b) Zoomed-up view

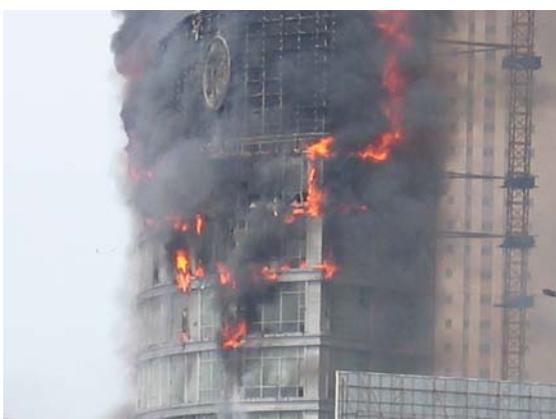
The fire was suspected to start from welding activities, igniting the combustibles piled at the top level, as reported in the news [1]. Heavy black smoke was observed throughout the city. Flames came out from windows in the top five storeys. Many burning materials dropped from the external wall with flame. The fire ‘spread’ down to the fifth storey from the top within 20 minutes. A sequence of the pictures taken by the authors is shown in Fig. 2.

(c) Fire broken out

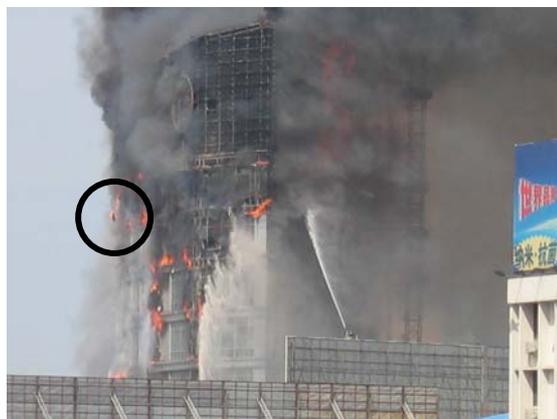
(d) Burning object fell down

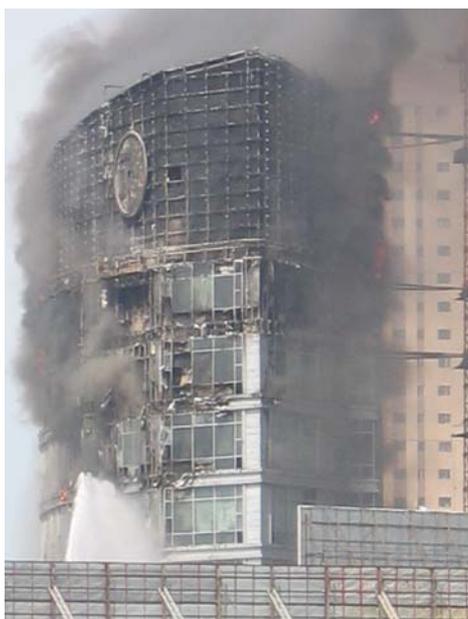
(e) Almost controlled

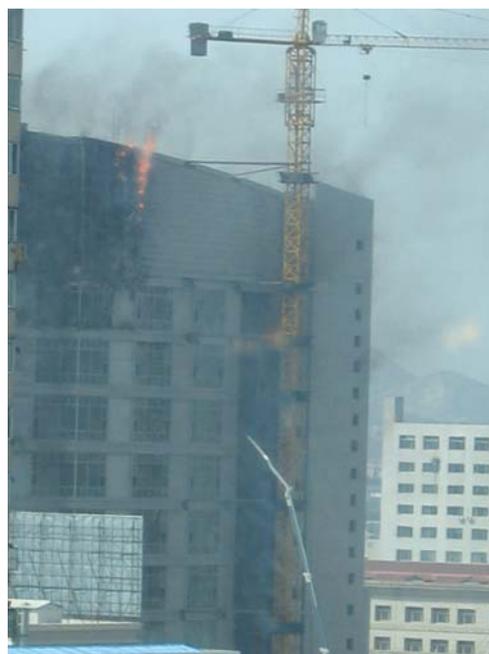
(f) Controlled
