## **PRELIMINARY EXPERIMENTAL RESULTS ON FIRE BEHAVIOUR OF TIMBER PARTITION MATERIALS WITH A ROOM CALORIMETER**

### **ABSTRACT**

Fire behaviour of timber partition materials were assessed in a room calorimeter with size following ISO 9705. Fourteen full-scale burning tests on timber materials used in the local industry with and without paint, wallpaper, fiberglass and fire retardant were carried out. The heat release rate, surface temperature of materials, upper layer gas temperature, floor heat flux and time to flashover were recorded. Flame spreading over the materials was observed.

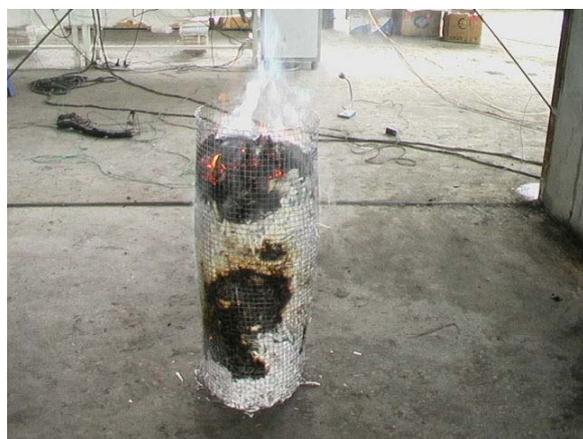
(a) Burning of paper basket

3 kg of paper strips were put in a basket of diameter 0.35 m. When the paper on the top was ignited, it burned quickly to ashes as shown in Fig. 2a. However, the paper in the lower part was not involved in burning due to insufficient air entrainment. The reproducibility in heat output was poor. Even when the paper strips were freely burnt on the floor, the fire size was not too big as shown in Fig. 2b. The paper strips should be turned for more oxygen supply to sustain burning.

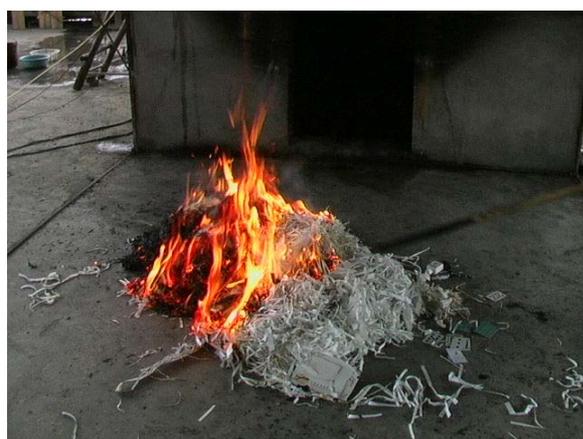
(b) Free burning of paper strips
