PRELIMINARY EXPERIMENTAL STUDY OF DOUBLE-SKINNED FAÇADE

W.K. Chow and W.Y. Hung

G.W. Zou, H. Dong and Y. Gao

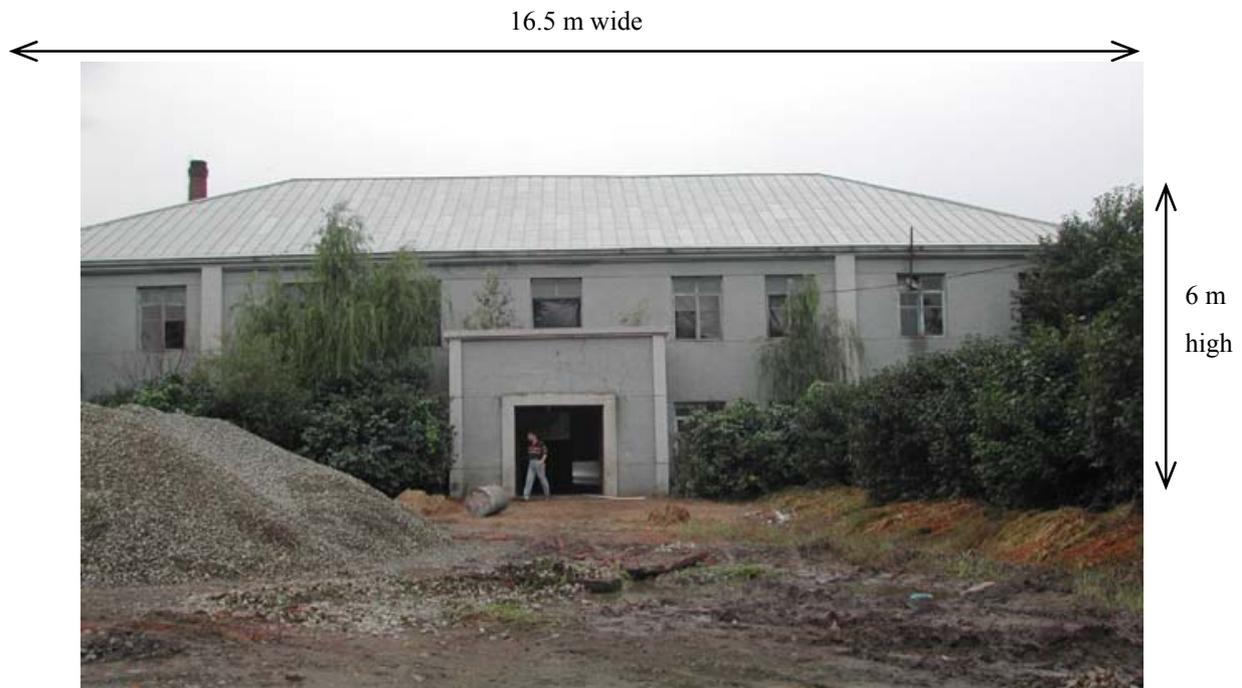
Fig. 2: External view of the burning hall in Lanxi

more open scientific developments. There is even stronger collaboration with China. An abandoned hall in a small town Lanxi in Harbin in Northeast China was rented as the laboratory to carry out the experimental study. The burning hall of 6 m high, 16.5 m long and 16 m deep, with a view shown in Fig. 2. Inside the hall, full-scale burning facilities on a double-skinned façade were constructed.

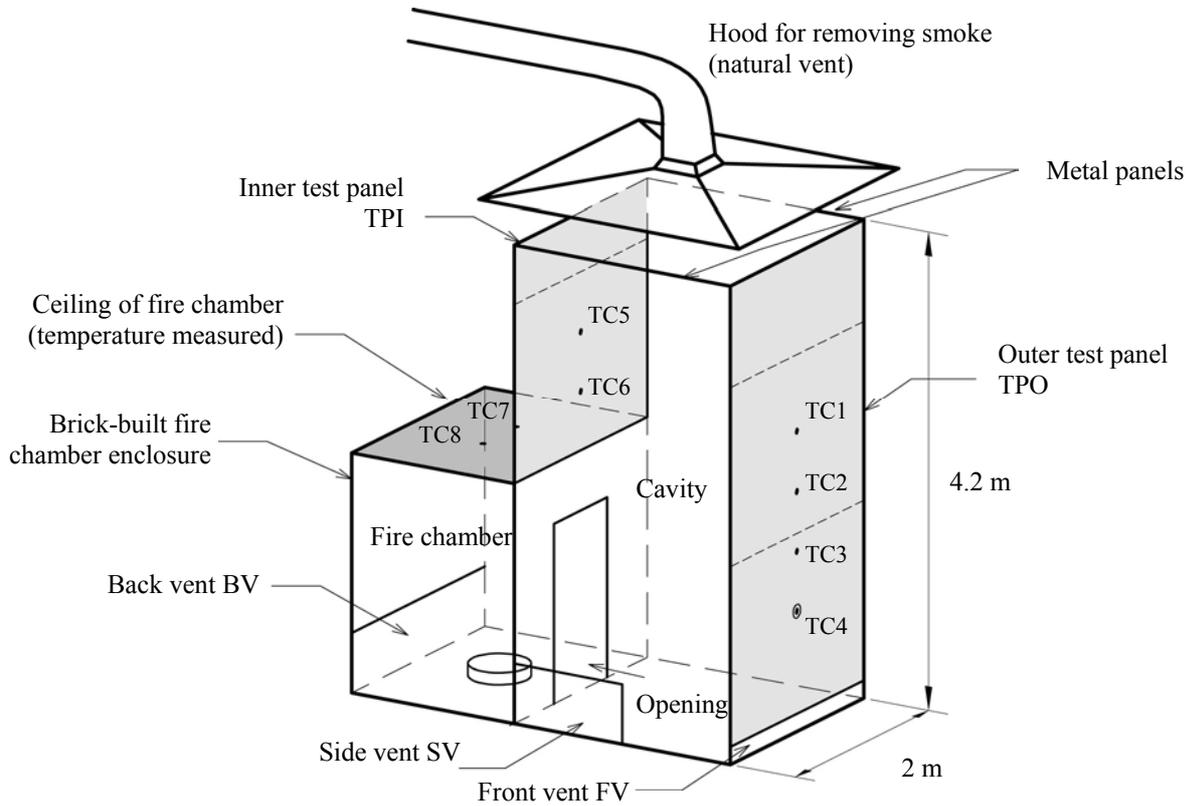
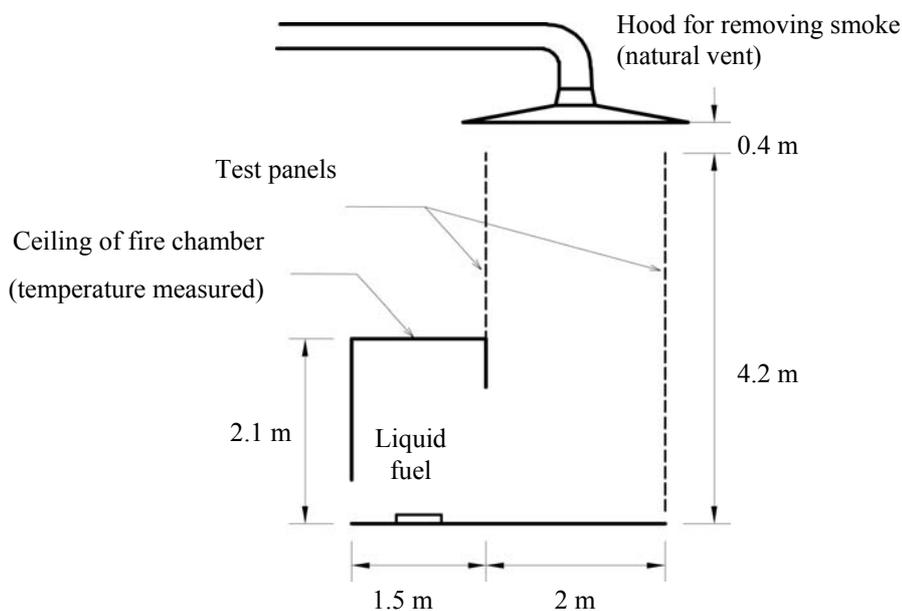
Fig. 3: Schematic diagram of the experimental setup

The experimental rig used was in an L-shape configuration with one fire room attached to a space demonstrating the cavity between the two

glass panes of a double-skinned façade, as illustrated in Fig. 3. The fire chamber was 2 m wide, 1.5 m deep and 2.1 m high and the cavity was 2 m wide, 4.2 m high and 2 m deep. Test panels TPO and TPI were demonstrating the outer skin and inner skin of the upper story respectively while the fire chamber acted as an occupied space in which a fire broke out.

(a) Schematic diagram of test rig

(b) Sectional view

Different openings were arranged on the test rig, namely a front vent FV of area 0.3 m^2 (0.15 m by 2.0 m), a back vent BV of 1 m^2 (0.5 m by 2.0 m), a side vent SV of 0.5 m^2 (0.5 m by 1.0 m) and a top vent of 4 m^2 (2.0 m by 2.0 m), as shown in Fig. 3a. In this way, different opening conditions were used in different tests, as shown in Table 1. The measured surface temperatures were different under different opening conditions. Different combinations of openings were used in the preliminary tests, say opening the back and top vents in test W1, and opening the side and top vents in test W3. The top of the cavity was left open in all tests. Otherwise, temperatures measured would be extremely high due to the trapped hot gases and smoke inside the cavity. Moreover, they were supposed to move upwards in

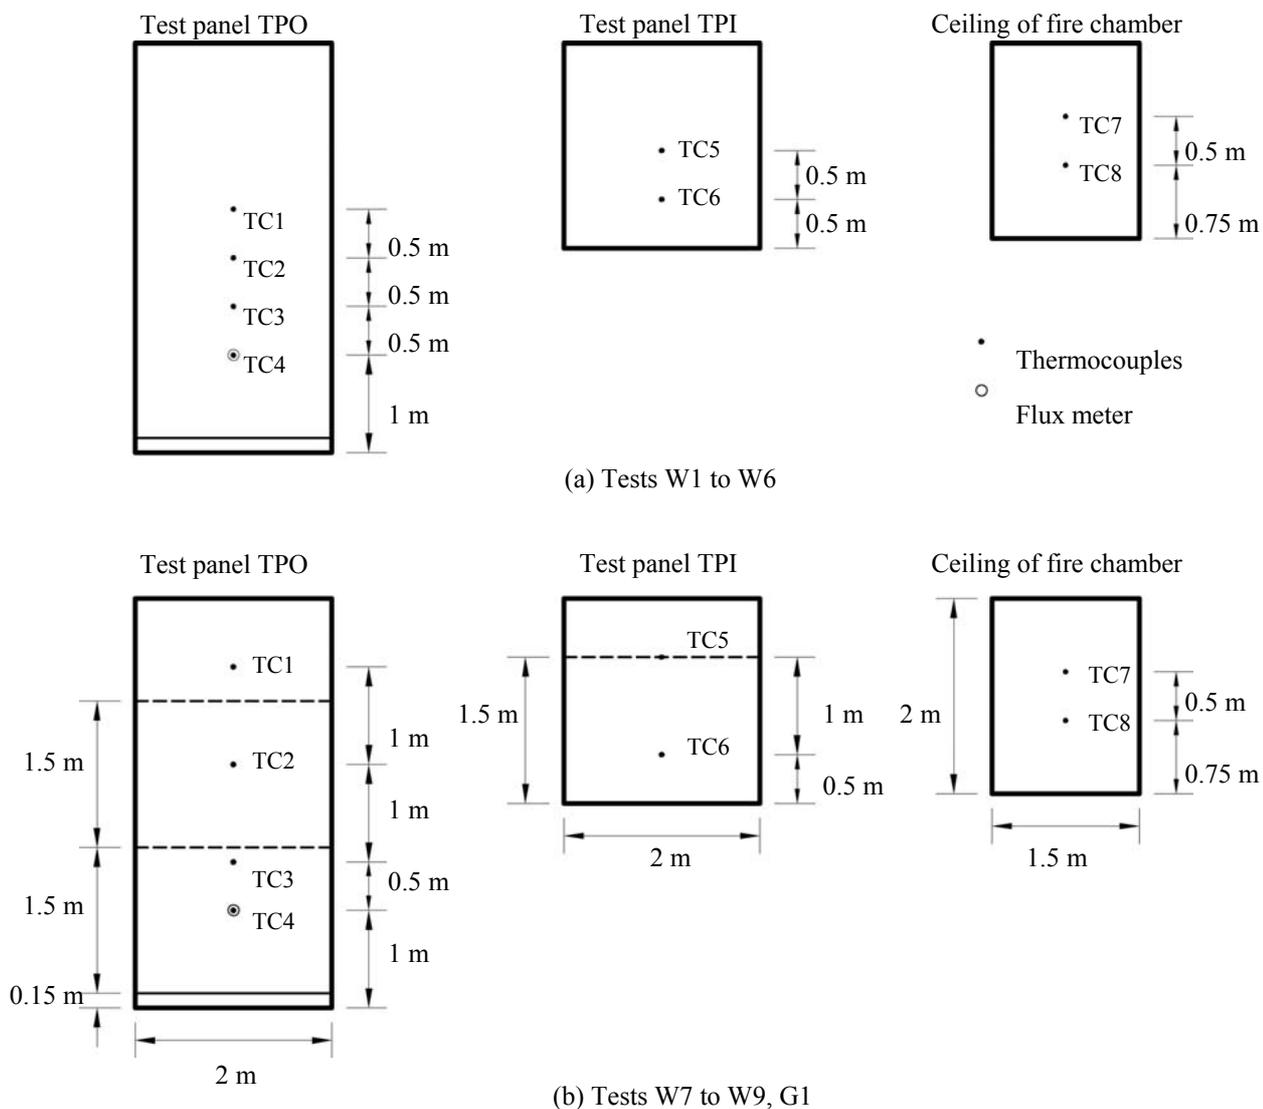
Fig. 4: Locations of thermocouples and heat flux meters

availability. In Fig. 4, the locations of thermocouples and flux meters were illustrated. Points TC1 to TC4 were located on the outer panel TPO; points TC5 and TC6 were located on the inner panel TPI and points TC7 and TC8 were used to measure the temperature at the top of the fire chamber.

As shown in Fig. 5, the enclosure of the fire room was constructed of brick which is not combustible. A vent of size 1.5 m high and 0.8 wide was left open to the cavity so that flame and smoke were able to pass through. The cavity wall was constructed by galvanized sheet steel. The two test wood panels were a species of poplar of 4 mm thickness. The test glass panels, of 3.5 mm thick, were common glass panels used for curtain wall available in the nearby regions. The available glass pane was 2 m wide and 1.5 m high, so that glass panes were cropped to suitable dimensions to compose full height of the walls, as shown in Fig. 4b.

Only one heat flux meter was available in this experiment due to limitation of resources. It was located on the outer test panel TPO as illustrated in Fig. 4. By positioning it directly to face the fire source, the highest incident heat flux onto the outer skin from the fire chamber can be measured. The heat flux profiles of the two tests are shown in Fig. 10. The maximum heat flux measured in tests W8 and W9 was about 5 kWm⁻².

Due to limited resources, the outer skin of the glass panel was composed by three smaller glass panes, as shown in Figs. 4b and 6. It is believed that glass pane of smaller area would be stiffer than that of larger area [4]. Large piece of glass would undergo larger temperature difference between the edge and the centre and higher thermal stress would be resulted. In this experiment, it has already been demonstrated that the glass panels cannot endure high heat environment. Cracks would be generated and fallout of pieces is likely to occur. It would be very risky to the neighboring buildings and environment in reality.

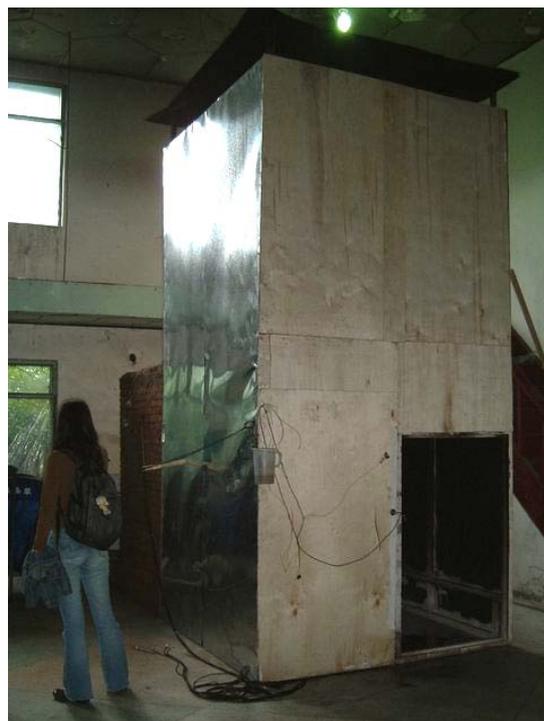
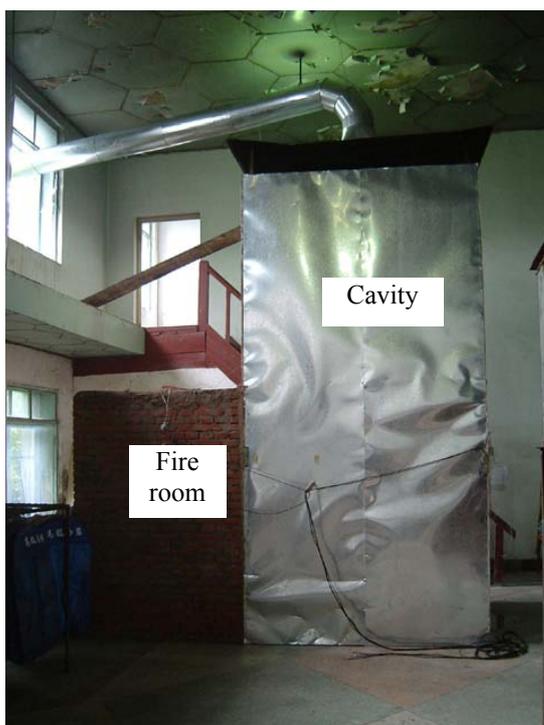
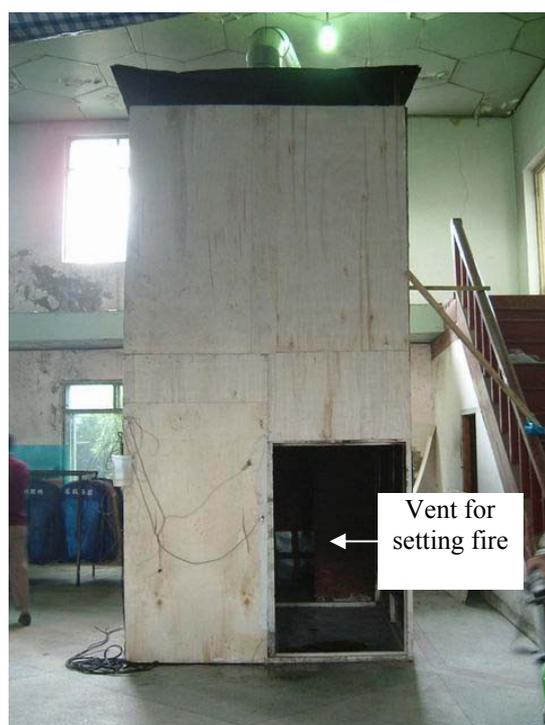
Fig. 5: Pictures of the test rig

(a) Appearance

(b) Elevation

(c) Front view

Smoke and hot gases were observed to be flowing upwards, affecting either the upper part of the outer test panel TPO or the inner test panel TPI. It was noted that opening the vent on wooden TPO was used for the ease of setting off the fire, as shown in Fig. 5c.

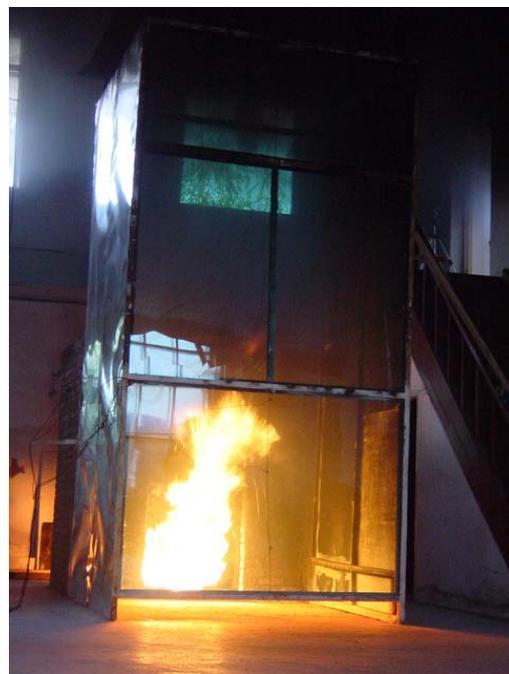
Fig. 6: Flame coming out from the fire chamber

Large quantity of smoke was generated in the tests, explaining why a hood and exhaust duct had to be installed on top of the test rig. However, mechanical extraction system was not provided without affecting the fire-induced flow. Moreover, flame was coming out from the fire chamber to the cavity as shown in Fig. 6.

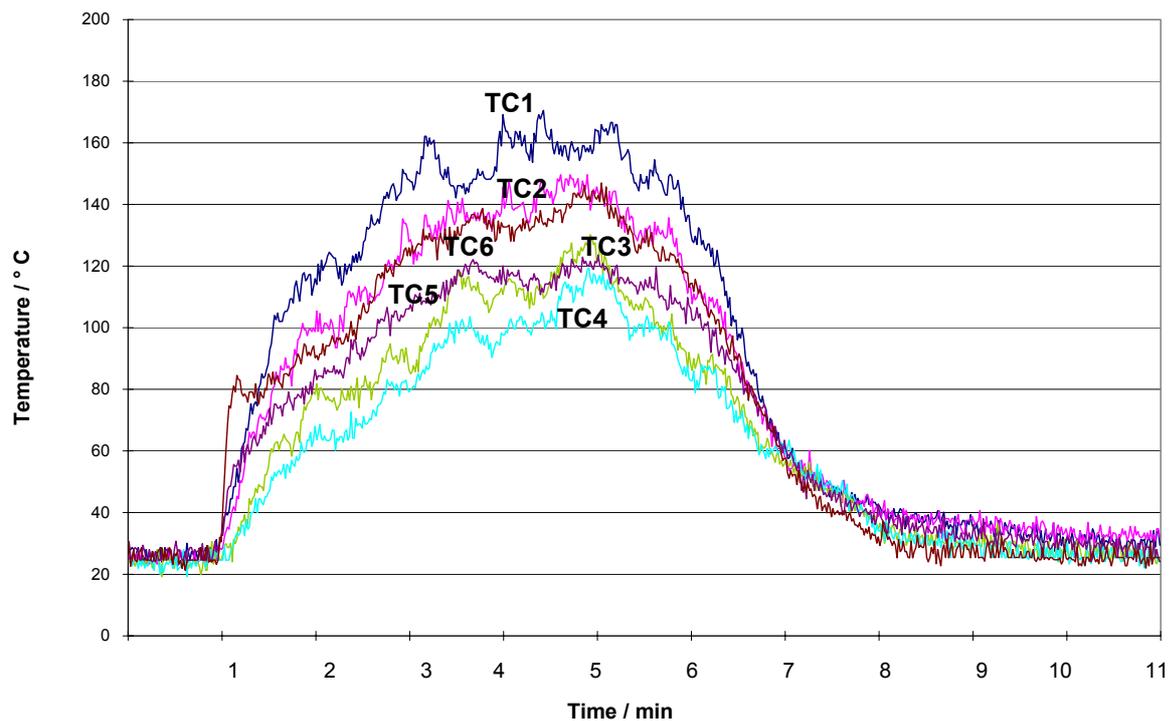
Fig. 7: Temperature profiles at TC1 to TC6 for test W8

The temperature profiles for tests W8, W9 and G1 are shown in Figs. 7 to 9. Tests W8 and W9 were carried out with wood panels; whilst G1 was conducted using glass panel. It was discovered that the two tests with wood panels took more than 3 minutes to reach the highest temperature. Test G1 with glass took more than 4 minutes to give the highest value. It is noted that the test preparation, such as pouring fuel and setting off the fire, was included in the time measurement.

From the results, points TC1 and TC6 had the highest temperature on TPO and TPI respectively. On the other hand, when comparing points on the same height, outer panel TPO would experience higher temperature than inner panel TPI. It is also shown in Figs. 7 to 9 that the difference between TC1 and TC5 was larger than that between TC2 and TC6. All these implied that hot gases moved towards the outer skin of the double-skinned façade and had an inclination to the upper part, as illustrated in Fig. 1a.

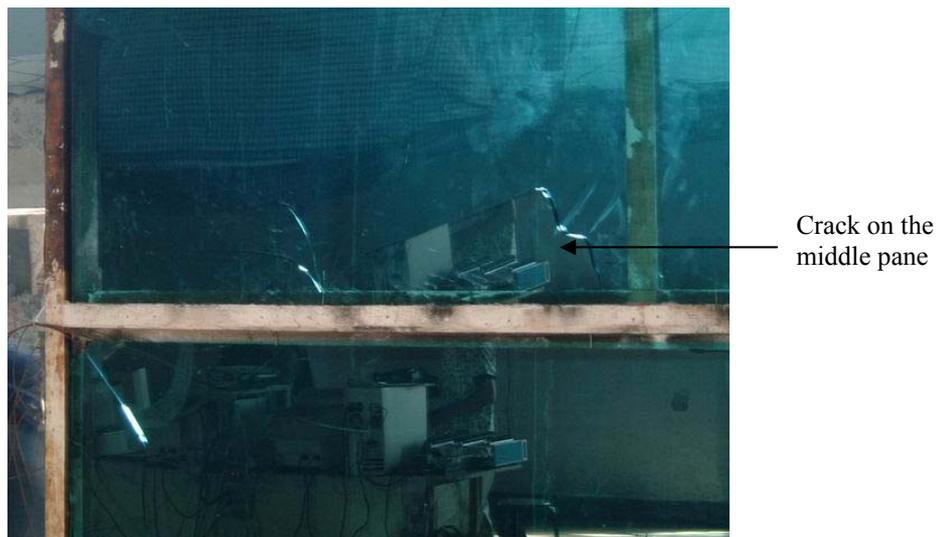
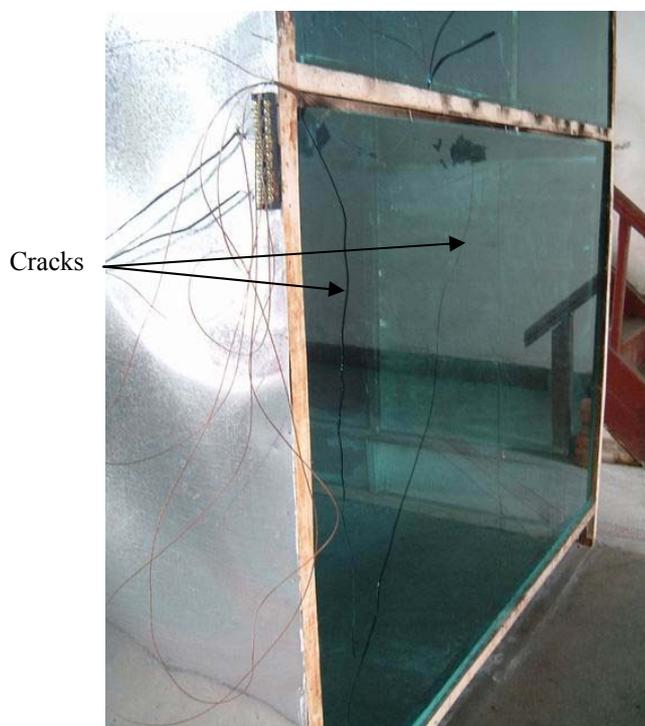
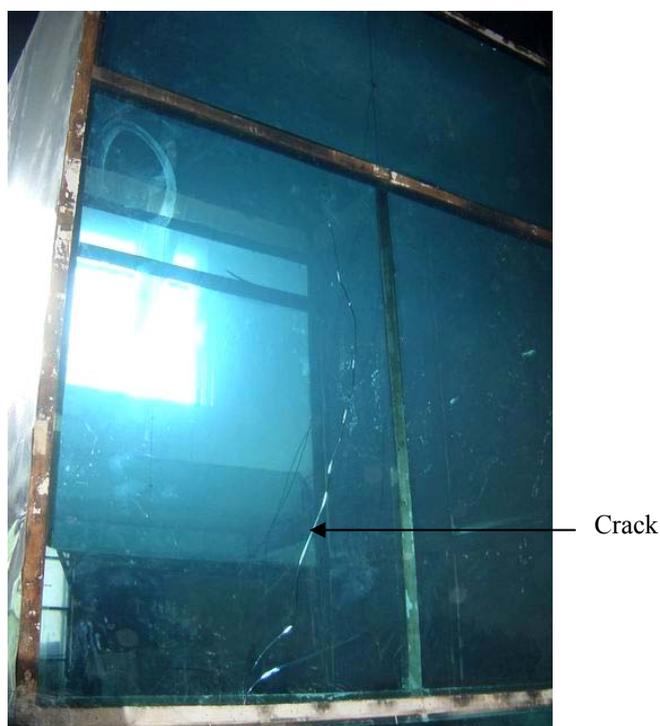
Fig. 11: Bifurcation patterns at the outer glass pane

Glass performance was observed in test G1. Cracking occurred on the outer panel TPO. The middle pane suffered the most serious cracking where it was initiated at the bottom of the pane. There were several crack bifurcation patterns, including one loop and some long cracking lines running up to the top of the pane. On the other hand, there was only one cracking line running through the pane on the uppermost one and two running through the lowest one. There was however no observed bifurcation pattern on the glass panel TPI. Fallout of glass pane was not encountered in this test. Cracking patterns are shown in Fig. 11. Time to give the first crack was not recorded in this study.

(a) Middle pane

(b) Lower pane

(c) Another view

In the last test G1, 3.5 mm thick glass panes of size 2 m x 1.5 m commonly used was utilized by fixing several pieces to give panels of full height. Wood frames were used to stabilize the glass panes. Performance of glass in a double-skinned façade exposed under heat was demonstrated and bifurcation pattern could be observed.
