# ASSESSMENT OF FIRE BEHAVIOUR OF TIMBER PARTITION MATERIALS WITH A ROOM CALORIMETER

Fire behaviour of timber partition materials were assessed in a room calorimeter with size following ISO 9705. Fourteen full-scale burning tests on timber materials used in the local industry with and without paint, wallpaper, fiberglass and fire retardant were carried out. The heat release rate, surface temperature of materials, upper layer gas temperature, floor heat flux and time to flashover were recorded. Flame spreading over the materials was observed.

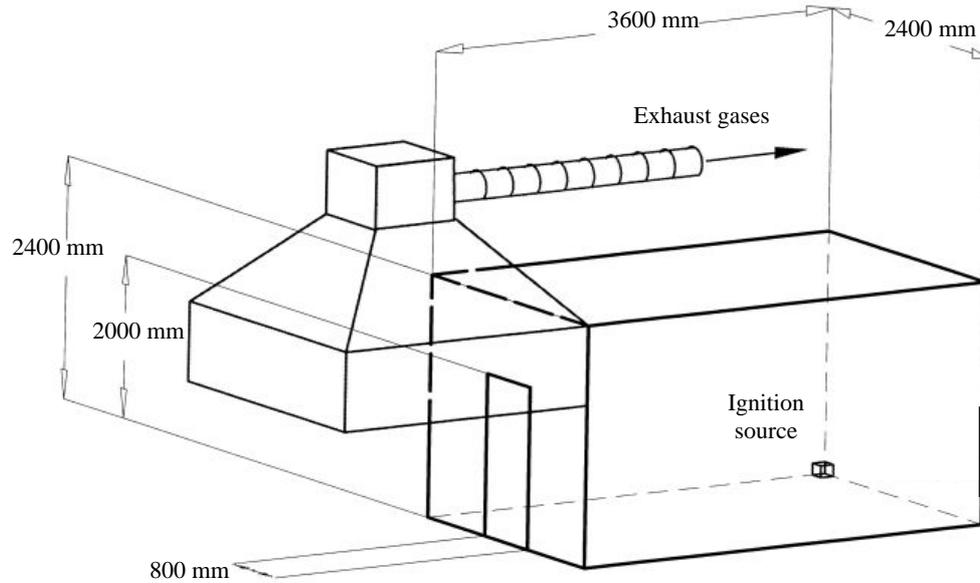
Fourteen full-scale burning tests on timber products, paint, wallpaper, fiberglass backing and fire retardant were carried out. Those are common materials used in the local industry. Tests were done in the PolyU/HEU Assembly Calorimeter developed by The Hong Kong Polytechnic University (PolyU) and the Harbin Engineering University (HEU) in a remote site in Lanxi, Harbin, China. An exhaust hood was built to collect combustion products and smoke generated from burning combustibles. The hood was connected to a fan-duct exhaust system at an extraction rate of  $3.5 \text{ m}^3\text{s}^{-1}$ . A 'duct section' with gas sampling tubes and sensors was installed in the exhaust duct and connected to an instrument station for further data analysis and determination of heat release rate using the oxygen consumption method. A room calorimeter was built according to the standard ISO 9705 [4] adjacent to the hood. The room is 3.6 m long, 2.4 m wide and 2.4 m high with a doorway 0.8 m wide and 2.0 m high as shown in Fig. 1. The walls are 0.24 m thick, constructed with bricks and concrete.

**Fig. 1: Configuration of the ISO 9705 full-scale burning test facility**

A heat flux meter is located at the center of the floor, 0.15 m above ground level, for measurement of the floor heat flux. Two Type K stainless steel sheathed thermocouples were mounted 30 mm below the ceiling, at the symmetrical center of the ceiling and above the ignition source for measuring the upper layer gas temperature. The time for flame emerging the doorway are also observed. Those three measurements and observations are useful indications of the time to flashover (TTF).

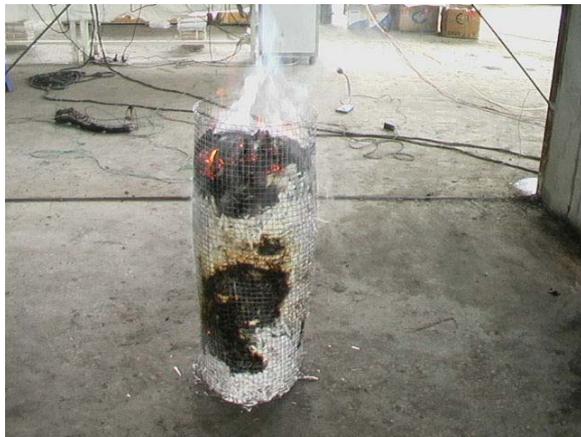
**Fig. 2a: Burning of paper basket**

3 kg of paper strips were put in a basket of diameter 0.35 m. When the paper at the top was ignited, it burned quickly to ashes as shown in Fig. 2a. However, the paper in the lower part was not involved in burning due to insufficient air entrainment. The reproducibility in heat output was poor. Even when the paper strips were freely burnt on the floor, the fire size was not too big as shown in Fig. 2b. The paper strips should be turned for more oxygen supply to sustain burning.

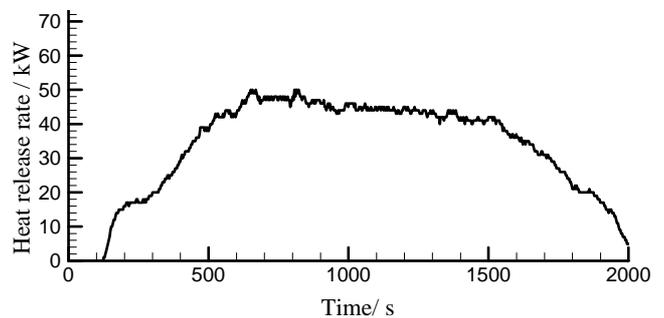
**Fig. 3a: Heat release rate curve of ignition source: 0.26 m × 0.26 m by 0.26 m high with 2000 ml gasoline located at left-rear wall corner**

Square containers were used to produce a pool fire. The ignition sources are burnt in the left-rear wall corner. 2000 ml gasoline was used in a 0.26 m × 0.26 m by 0.26 m high container. A steady heat output of around 45 kW was given for 1000 s which is over 50 % of the total burning time as shown in Fig. 3a. In another 0.35 m × 0.35 m by 0.25 m high container, 3500 ml gasoline was used. The heat output was over 120 kW for over 60 % (around 700 s) of the total burning time (around 1000 s) as shown in Fig. 3b.

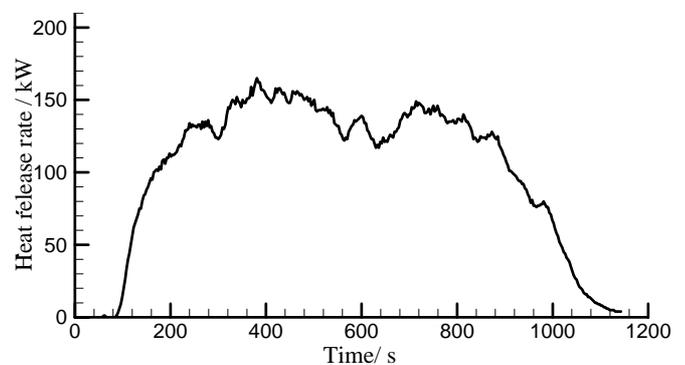
**Fig. 3b: Heat release rate curve of ignition source: 0.35 m × 0.35 m by 0.25 m high with 3500 ml gasoline located at left-rear wall corner**

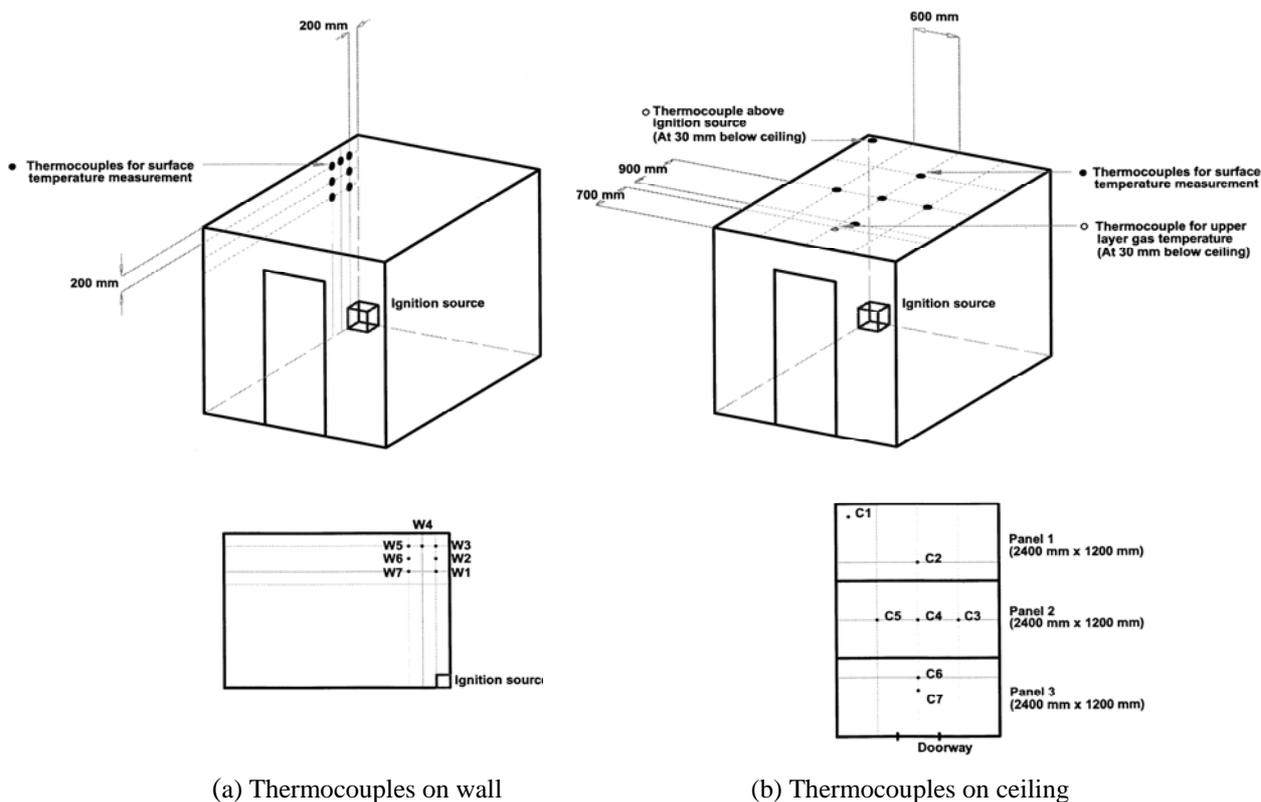
**Fig. 4: Locations of thermocouples for measurement of surface temperature and upper layer gas temperature**

Thermocouples were fixed on the left sidewall and ceiling materials as shown in Figs. 4a and 4b for measurement of surface temperature.

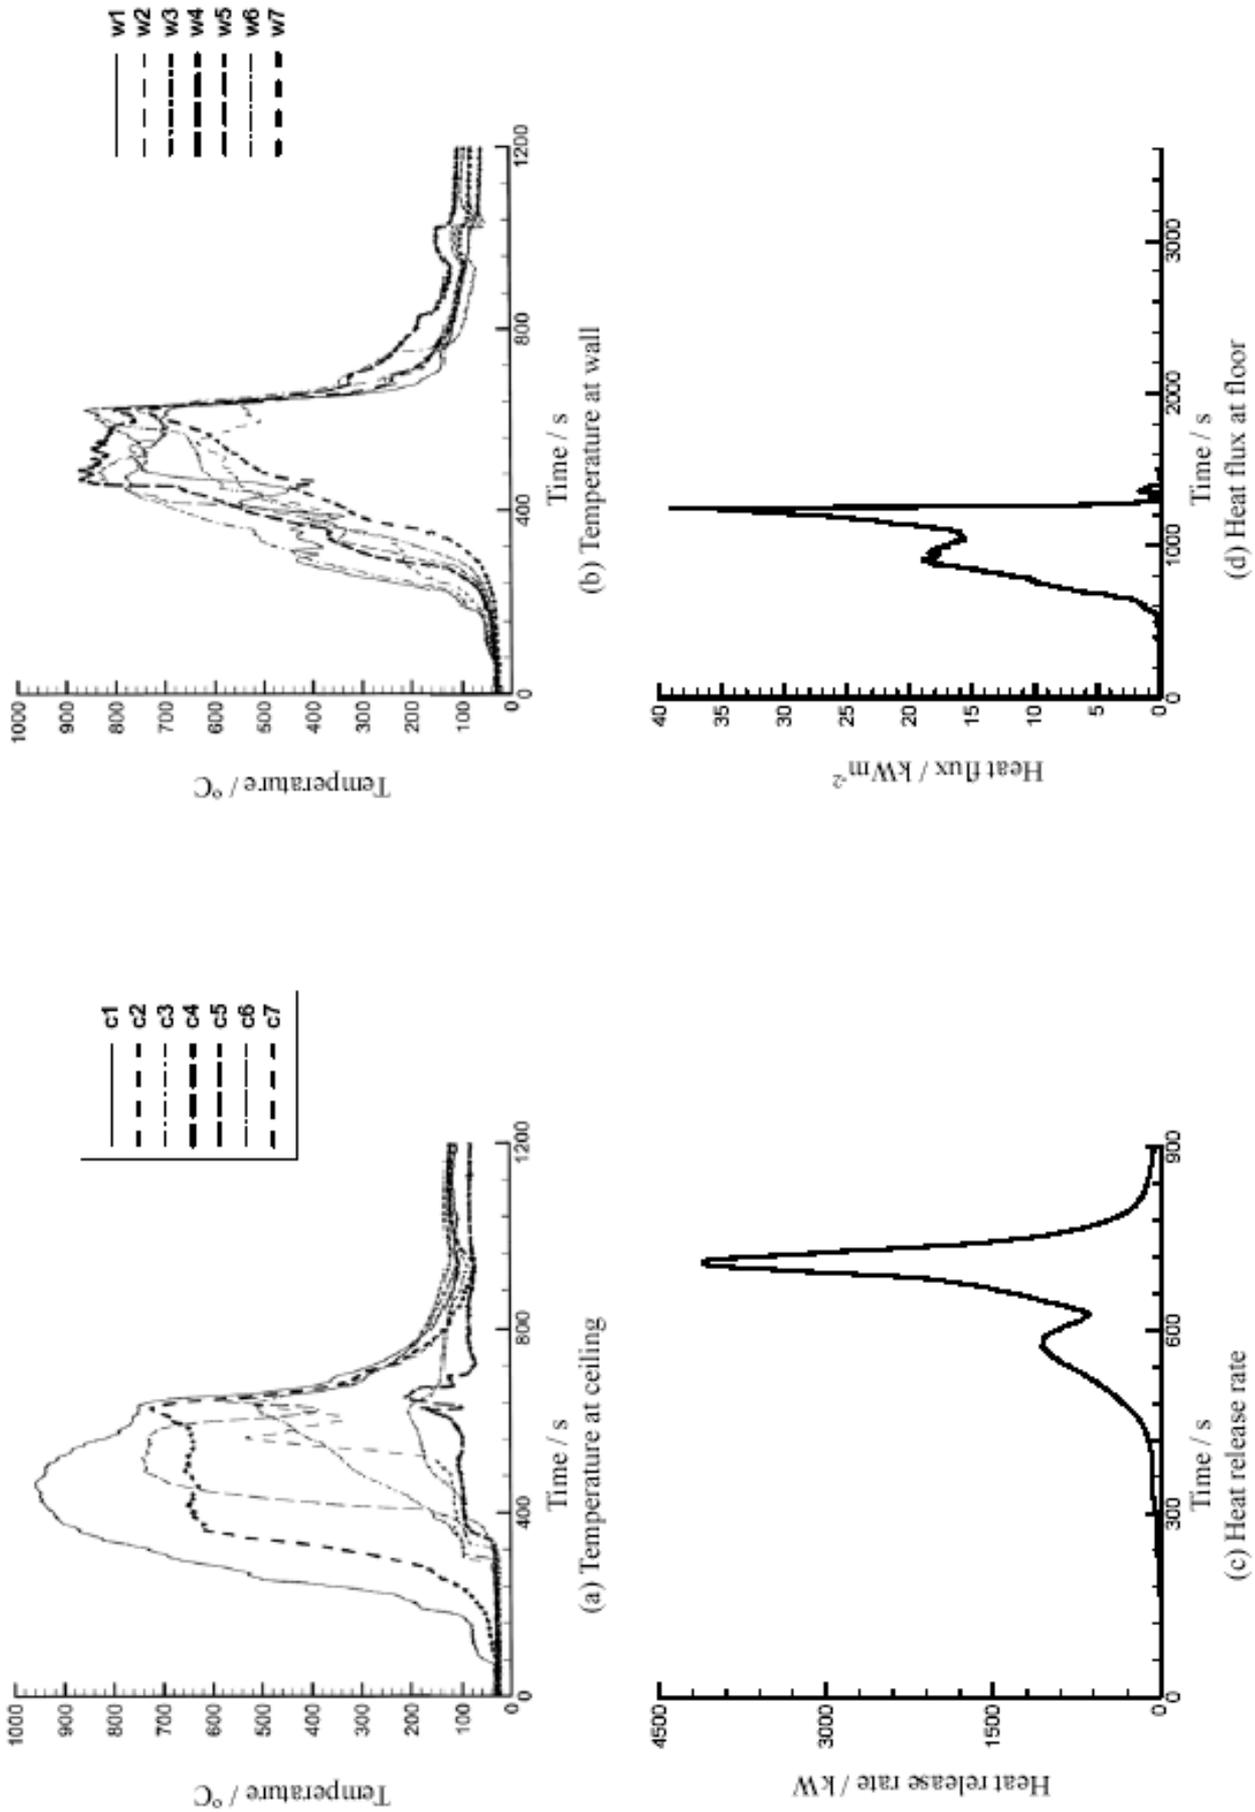
Fig. 5: Testing results for M1a

For M1a, the left sidewall and rear wall behind the ignition source were ignited at 159 s. Flame emerged the doorway at 351 s and heat release rate of 1 MW was recorded at 564 s. For M1b, a longer time was required for ignition, at 285 s. There was only very limited burning and char was formed over the surface of material. No flashover occurred in the total testing period of 20 minutes. The chipboard was ignited at 152 s in M1c. A flame layer was formed over the ceiling at 452 s with flame emerging the doorway. A large fire plume came out of the opening at 892 s and heat release rate of 1 MW was reached at 945 s. With a painted

Test no.	Material	Observations
M1a	8 mm chipboard	Ignition of wall material behind burner at 159 s; Tip of flame reached ceiling at 220 s; Ignition of ceiling material above burner at 258 s; Flame layer over ceiling at 341 s; Flame emerging the doorway at 351 s; Water mist discharged at 626 s.
M1b	8 mm fire retarded chipboard	Ignition of wall material behind burner at 285 s; Tip of flame reached ceiling at 365 s; Ignition of ceiling material above burner at 838 s; Flame spread to ceiling panel 3 at 3045 s; Water mist discharged at 3425 s. Remark: Fire extinguished gradually and became smouldering when the flame spread to ceiling panel 3.
M1c	8 mm chipboard backed with 7 mm fiberglass insulation	Ignition of wall material behind burner at 152 s; Tip of flame reached ceiling at 292 s; Ignition of ceiling material above burner at 382 s; Flame spread to ceiling panel 2 at 452 s; Flame emerging the doorway at 504 s and flame size reduced; Large fire plume emerging the doorway at 892 s; Water mist discharged at 1029 s.

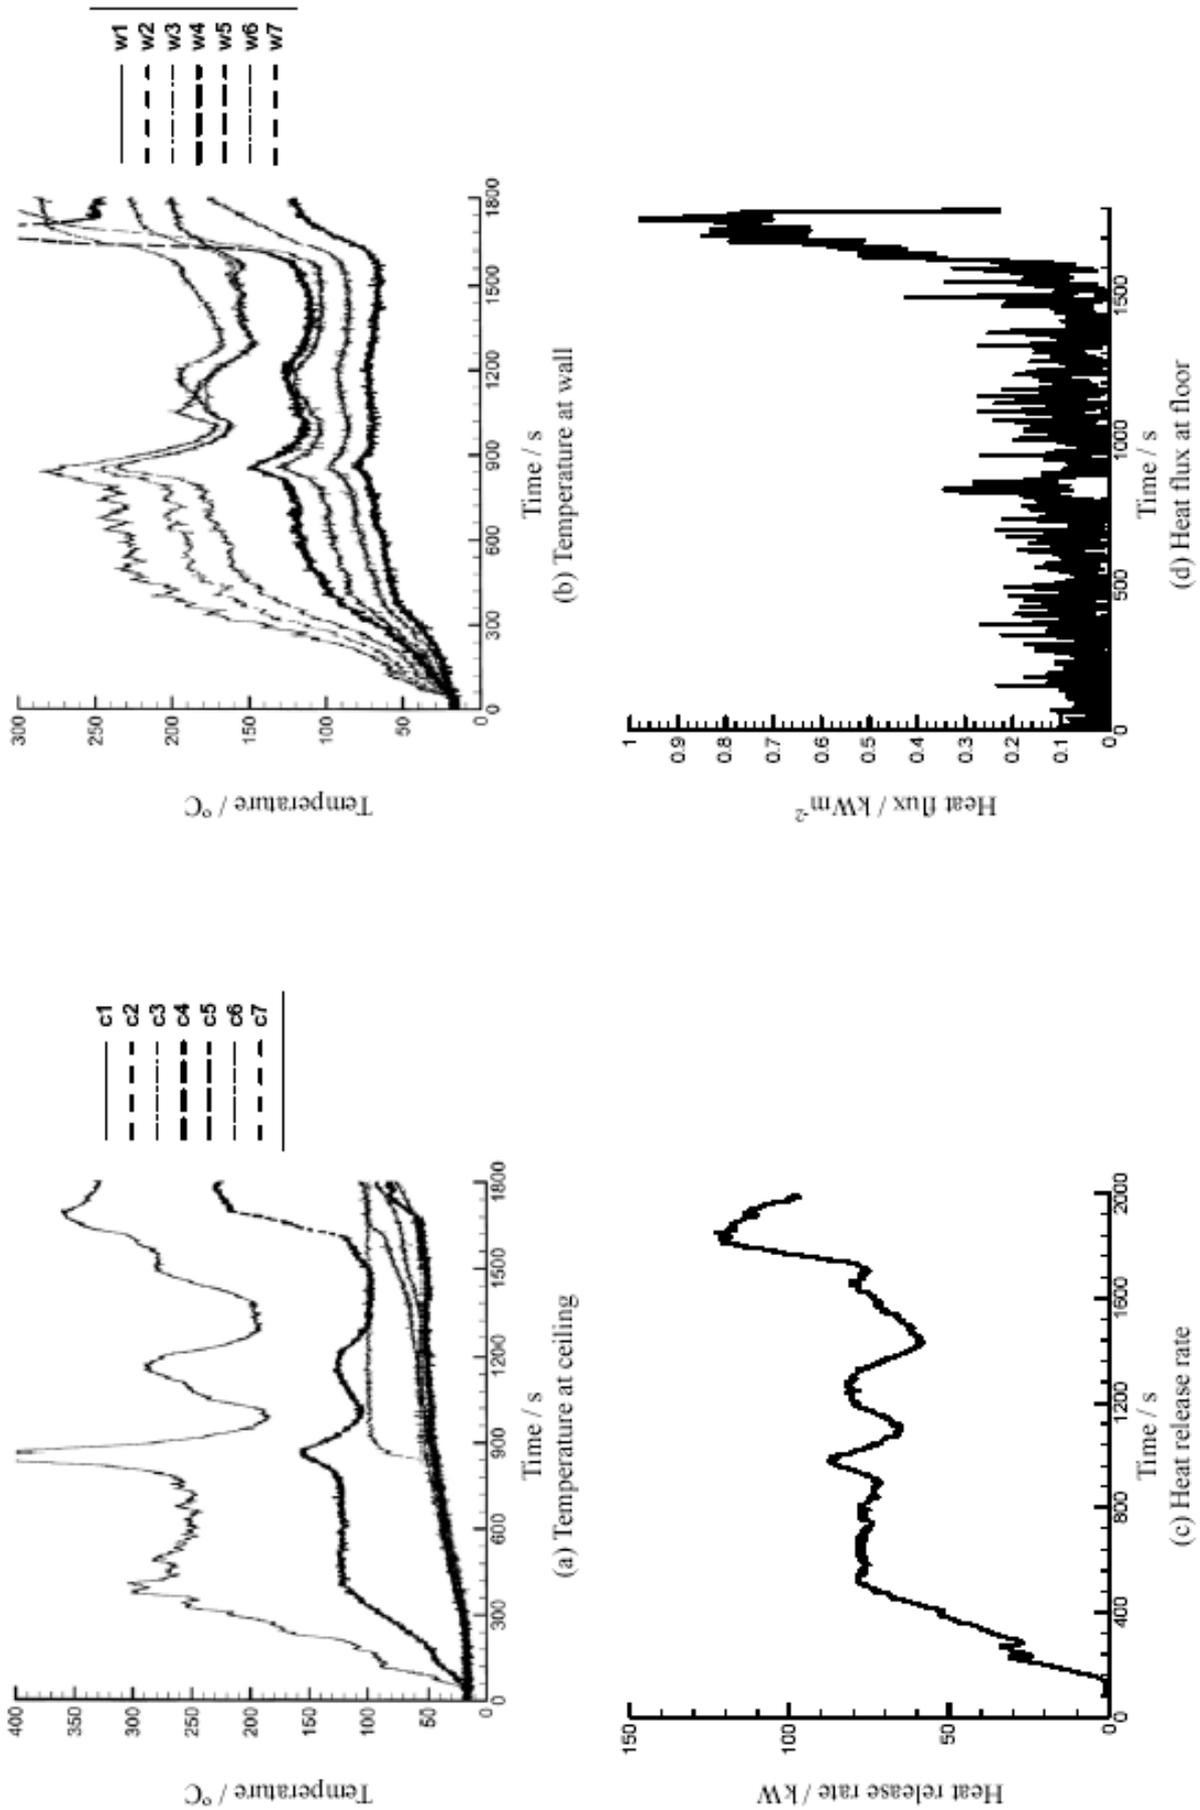
Fig. 6: Testing results for M1b

In testing chipboard with fire retardant (M1b) chipboard and paint with fire retardant (M1e) and chipboard and wallpaper with fire retardant (M1g), it was found that the application of fire retardant was the most effective in bare chipboard. The flame spread rate was much slower. Only very limited burning above the ignition source was observed. Forming of char over the wall surfaces prevented fire from spreading to other regions. The heat release rate was limited to be less than 100 kW. No flashover was recorded throughout the total testing period of 20 minutes. The application of fire retardant on wallpaper was still good where the flame spread rate was reduced. The trend in heat release rate was similar with a small peak and then a high peak leading to flashover. However, the TTF was much lengthened. The effect of the fire retardant over painted chipboard was significant. A high heat release rate of more than 800 kW was released at 500 s for the painted chipboard and then over 1 MW at flashover at 650 s. With the fire retardant coating, the first peak was much reduced to 300 kW and the TTF was 800 s.

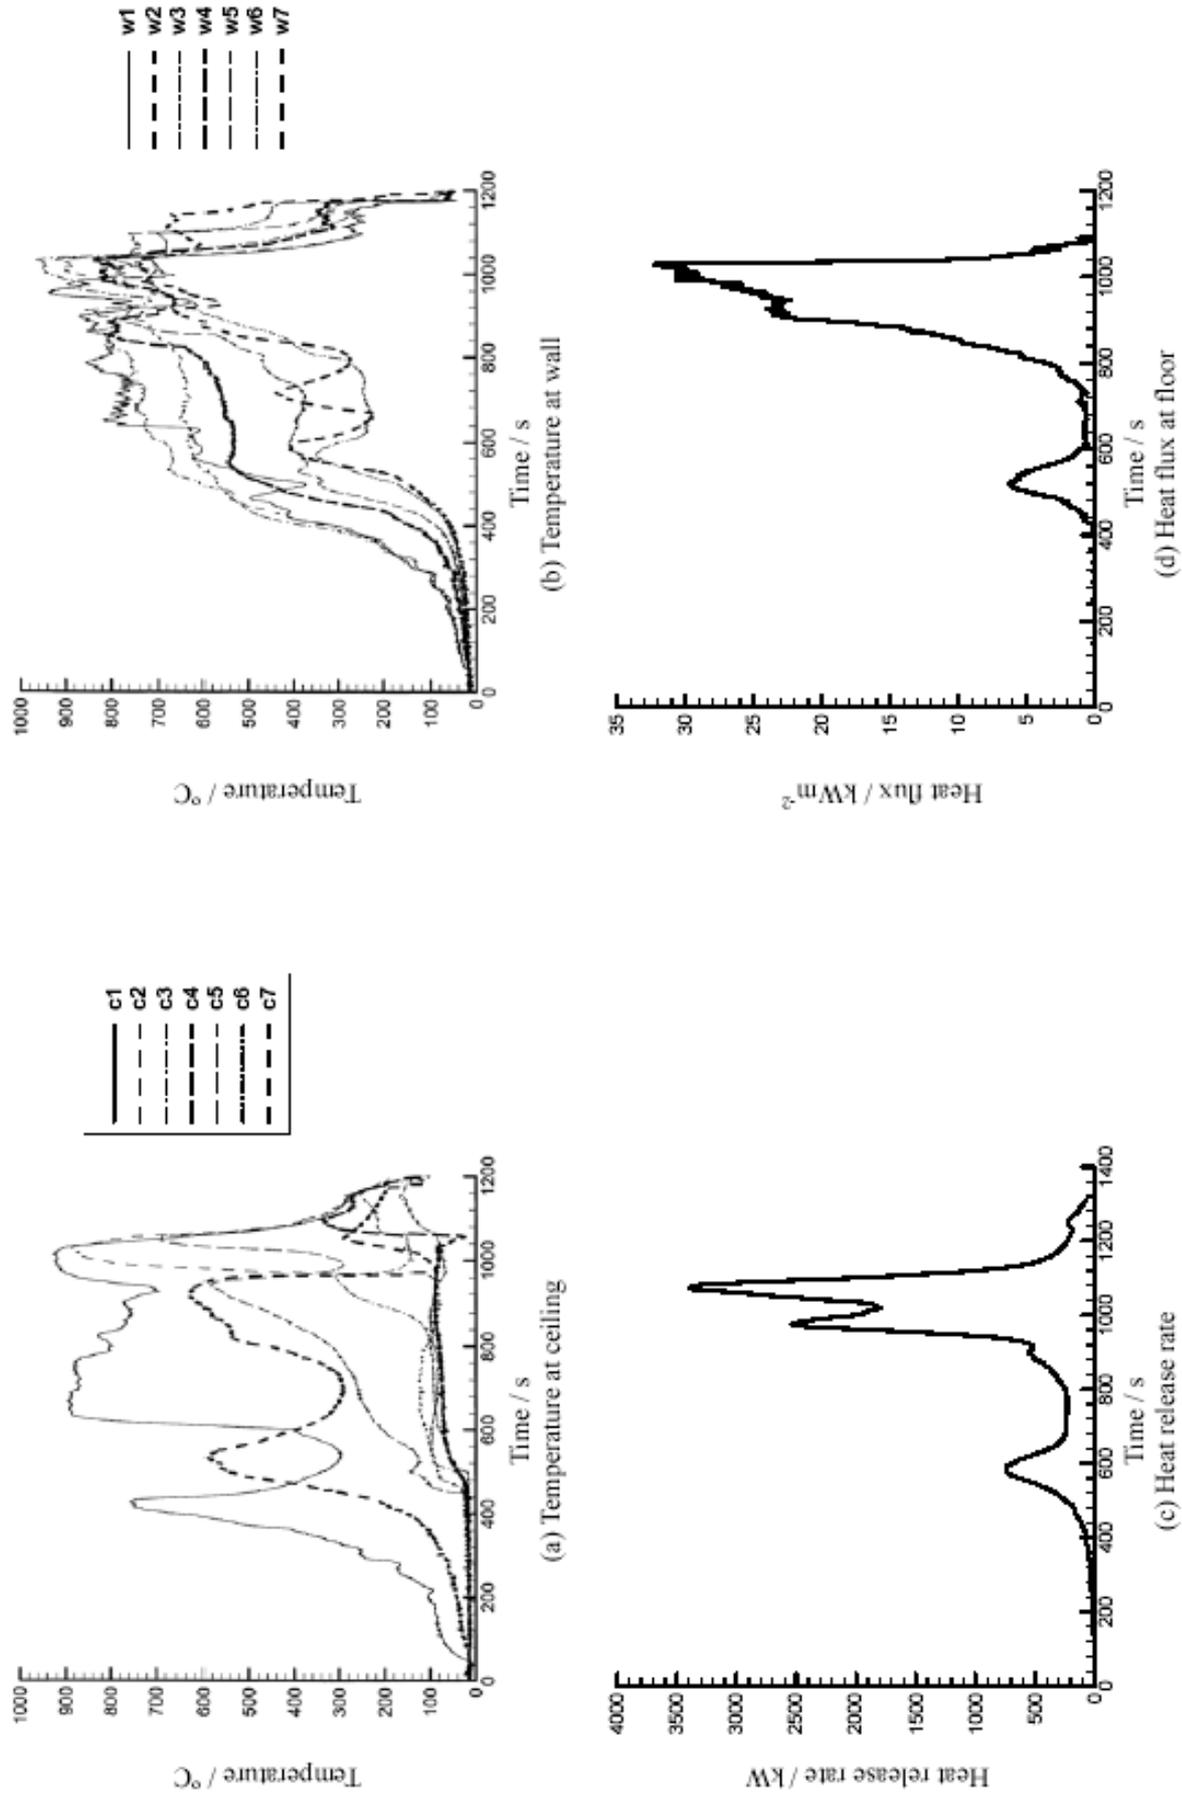
Fig. 7: Testing results for M1c

For the set M1, the testing on bare chipboard (M1a), chipboards with fiberglass (M1c), paint (M1d) and wallpaper (M1f) showed similar results. The time to ignition and flame spread phenomenon from the ignition source to the walls and ceiling are very close. In the tests M1d and M1f, the lateral flame spread from the burning region above the ignition source was comparatively faster than in the case of bare chipboard, though still only limited burning was seen. The flame spread in M1f was observed to be slightly faster, which might be due to the easier ignition and faster flame spread properties of the wallpaper and glue between the wallpaper and the chipboard. However, in comparing the TTF, no significant difference is observed from the tests, M1a, M1d and M1f. The TTF was the shortest in the testing of bare chipboard at 351 s. There was a rapid increase in heat release rate after ignition of the wall and ceiling materials. In other combinations, there was a small peak in heat release rate and then followed by a higher peak at around 1 MW at flashover. The TTF was 602 s for chipboard with paint (M1d) and 579 s for chipboard with wallpaper (M1f). This indicates that those finishing materials might enhance a faster spread of flame, but not necessarily give a shorter time to flashover. More full-scale burning tests should be carried out for further verification. The TTF was the longest in testing of chipboard with fiberglass backing, M1c. The flame spread rate was observed to be comparatively slower. The non-combustible fiberglass might behave as a heat sink behind the chipboard, causing more heat loss from the surface of the chipboard and thus slower surface flame spread.

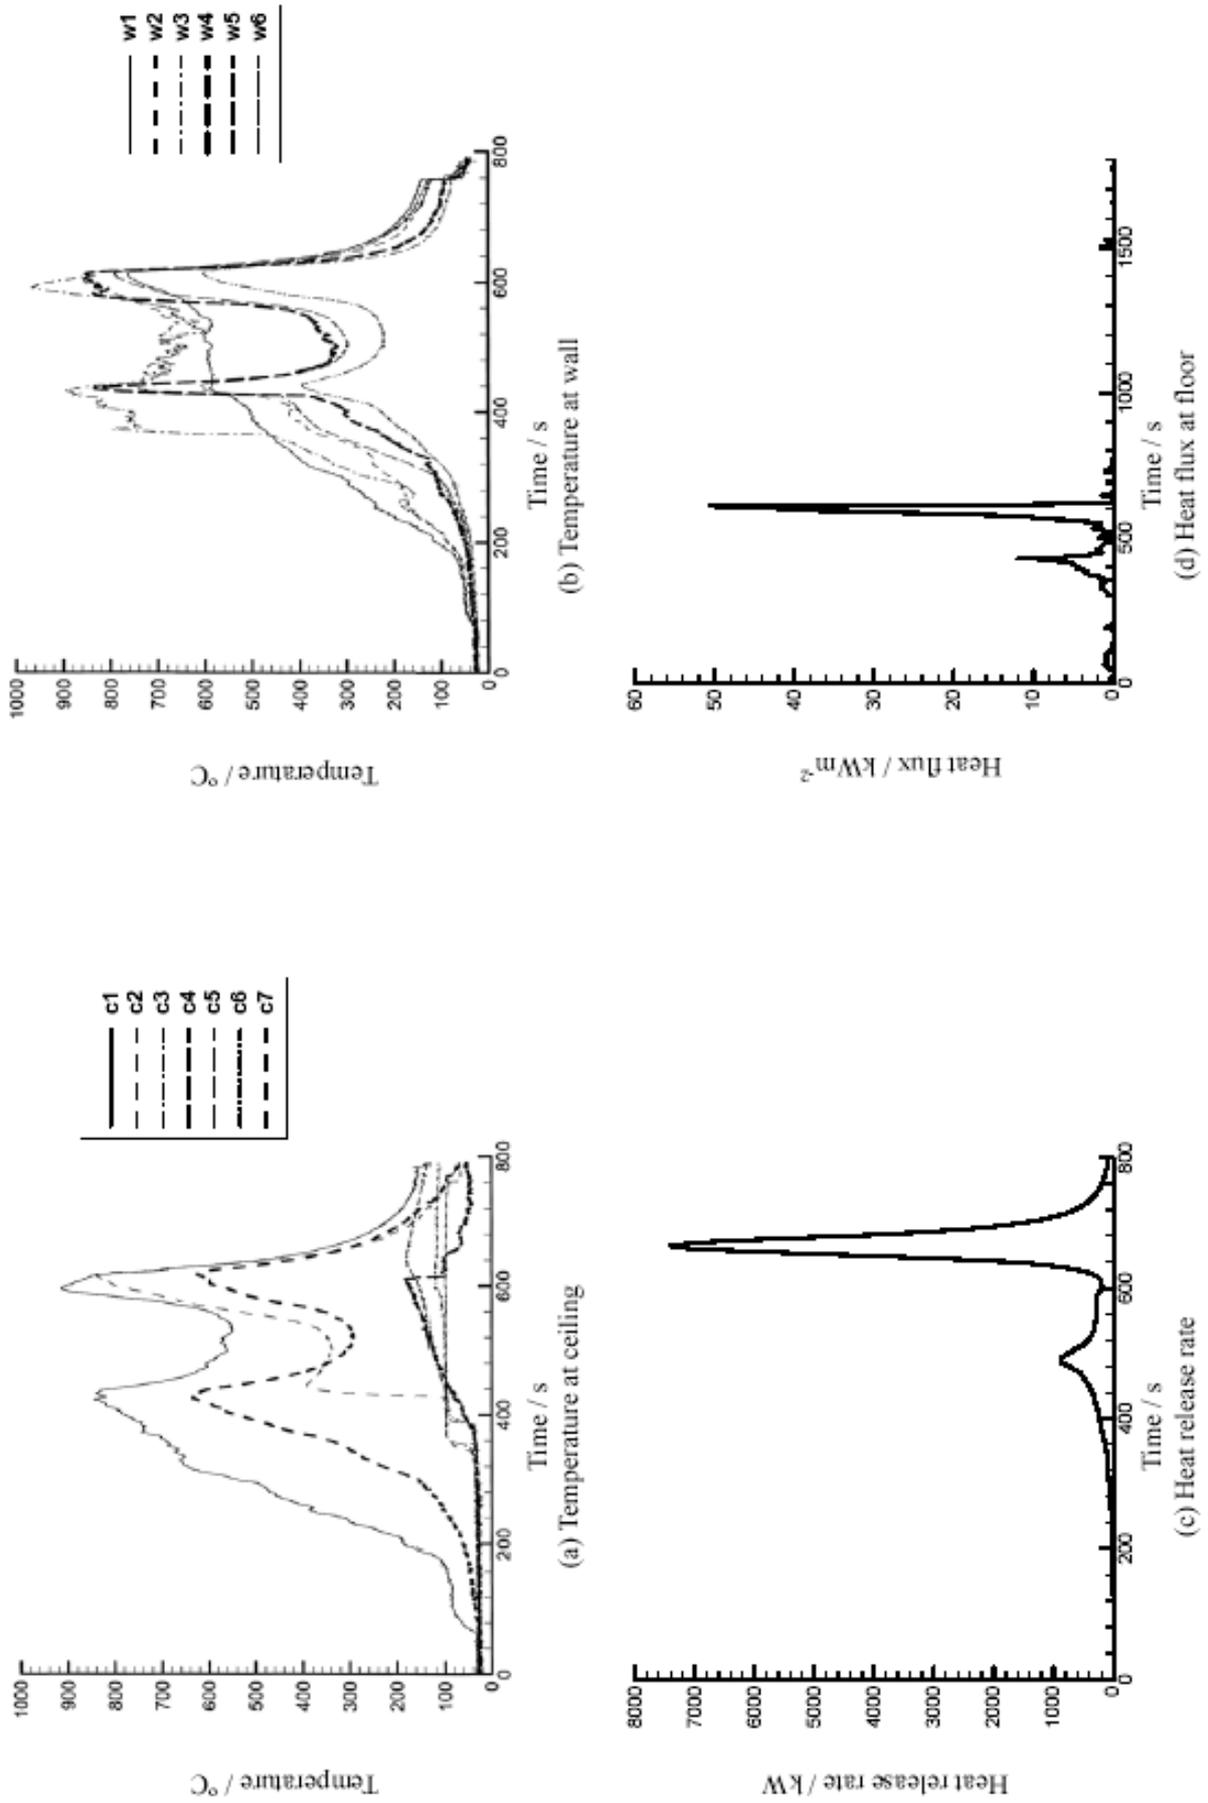
Fig. 8: Testing results for M1d

surface in M1d, the materials were ignited at 147 s. A ceiling flame layer was formed at 349 s with flame emerging at 582 s. Large fire plume came out of the doorway at 602 s. Heat release rate of 1 MW was recorded at 636 s. In M1e, ignition occurred at 208 s. Flame spread to ceiling, forming a flame layer at 488 s. Flame emerged the doorway at 730 s with a large fire plume out of the opening at 750 s. Heat release rate reached 1 MW at 804 s. For chipboard with wallpaper in M1f, ignition was observed at 139 s. Flame spread to ceiling at 299 s, causing one of the ceiling panels falling off. A flame layer formed over the ceiling and flame emerged at 579 s. Heat release rate reached 1 MW at 612 s. When fire retardant was added in M1g, the material was ignited at 174 s. The ceiling was ignited at 364 s and then ceased. Re-ignition occurred at 586 s and flame layer over ceiling was formed at 802 s. Flame emerged the doorway at 879 s and a large plume of fire emerged at 958 s. Heat release rate reached 1 MW at 999 s.

M1d	8 mm painted chipboard	Ignition of wall material behind burner at 147 s; Tip of flame reached ceiling at 222 s; Ignition of ceiling material above burner at 282 s; Flame spread to ceiling panel 2 at 349 s; Flame emerging the doorway at 582 s; Large fire plume emerging the doorway at 602 s; Water mist discharged at 612 s.
M1e	8 mm fire retarded chipboard with paint	Ignition of wall material behind burner at 208 s; Tip of flame reached ceiling at 238 s; Ignition of ceiling material above burner at 338 s; Flame spread to ceiling panel 2 at 488 s; Flame emerging the doorway at 730 s; Falling of ceiling panel and large fire plume emerging the doorway at 750 s; Water mist discharged at 801 s.
M1f	8 mm chipboard with wallpaper	Ignition of wall material behind burner at 139 s; Tip of flame reached ceiling at 209 s; Ignition of ceiling material above burner at 237 s; Flame spread to ceiling panel 2 at 299 s; Falling of ceiling panel 2 at 468 s; Flame layer over ceiling and large fire plume emerging the doorway at 579 s; Water mist discharged at 624 s.

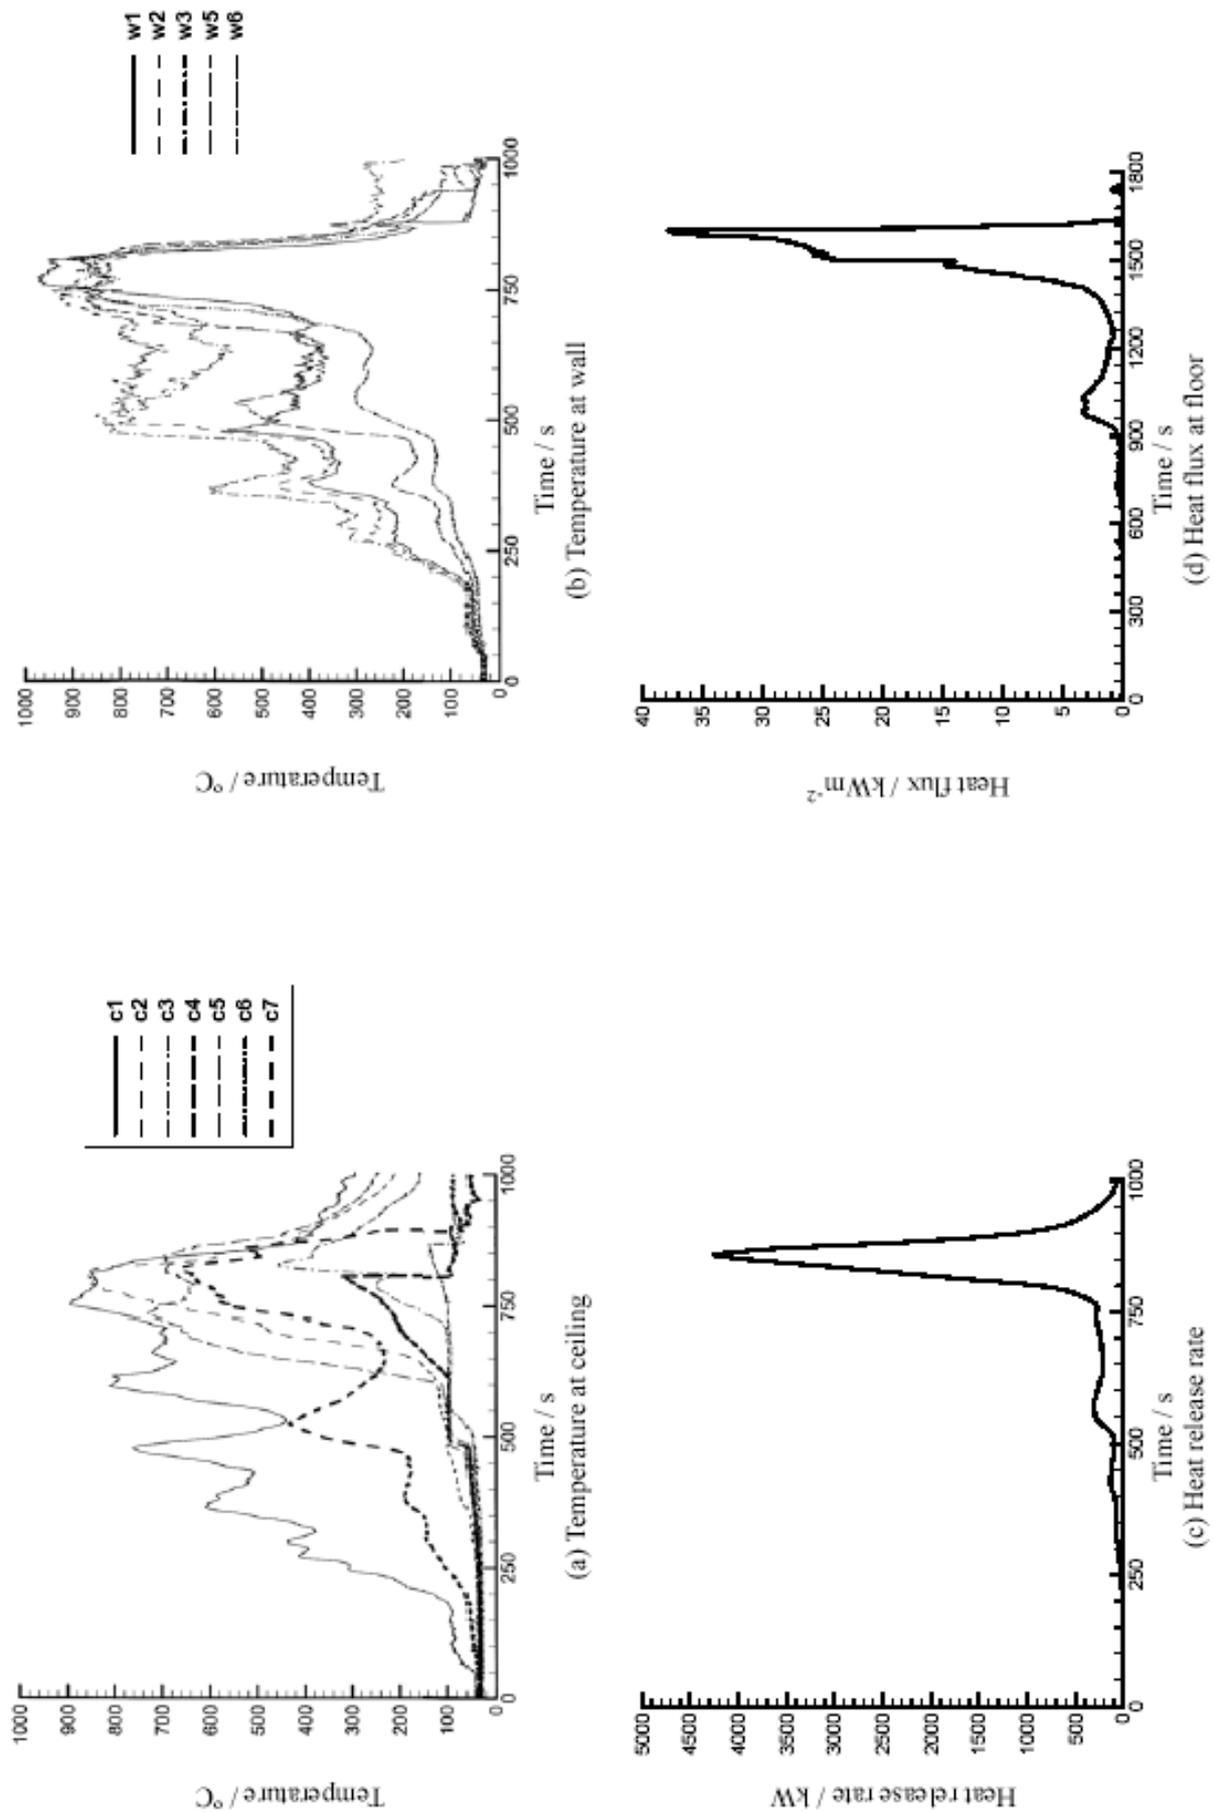
Fig. 9: Testing results for M1e

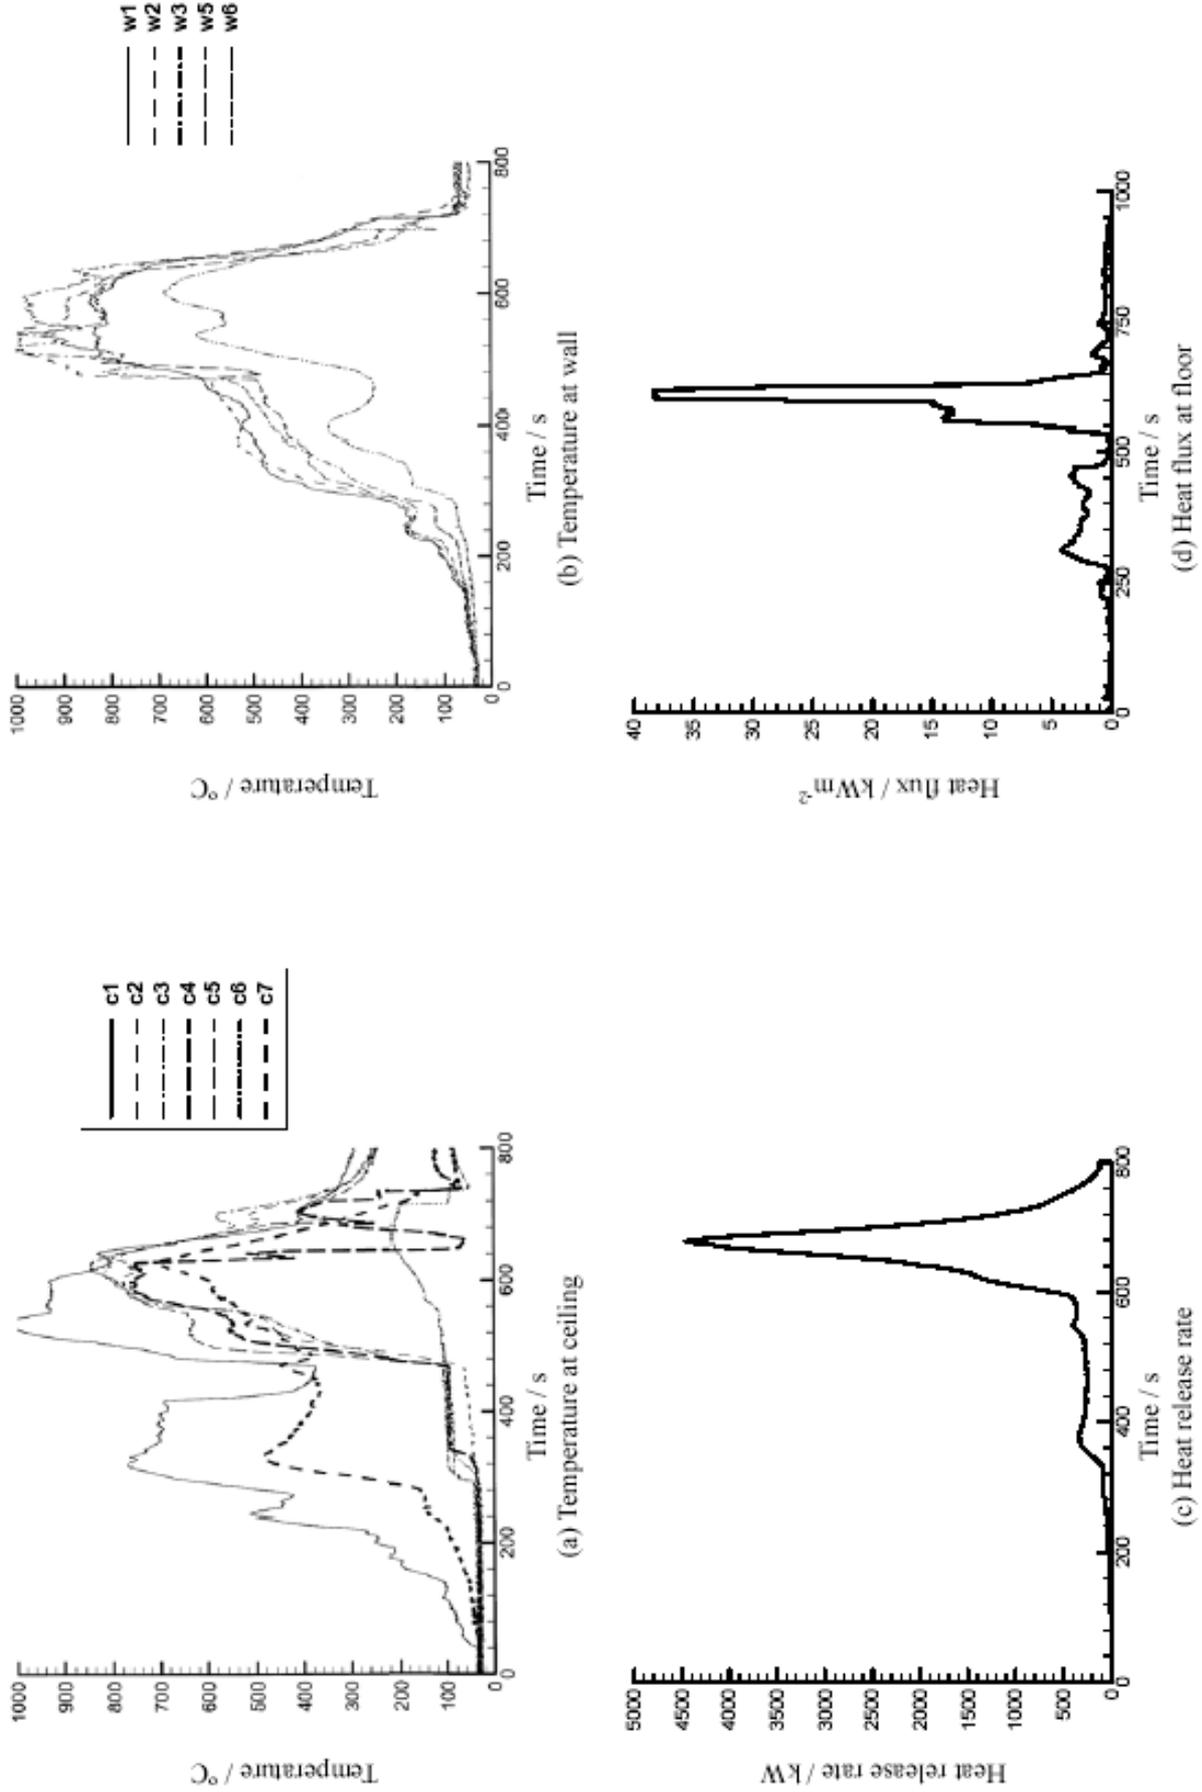
Fig. 10: Testing results for M1f

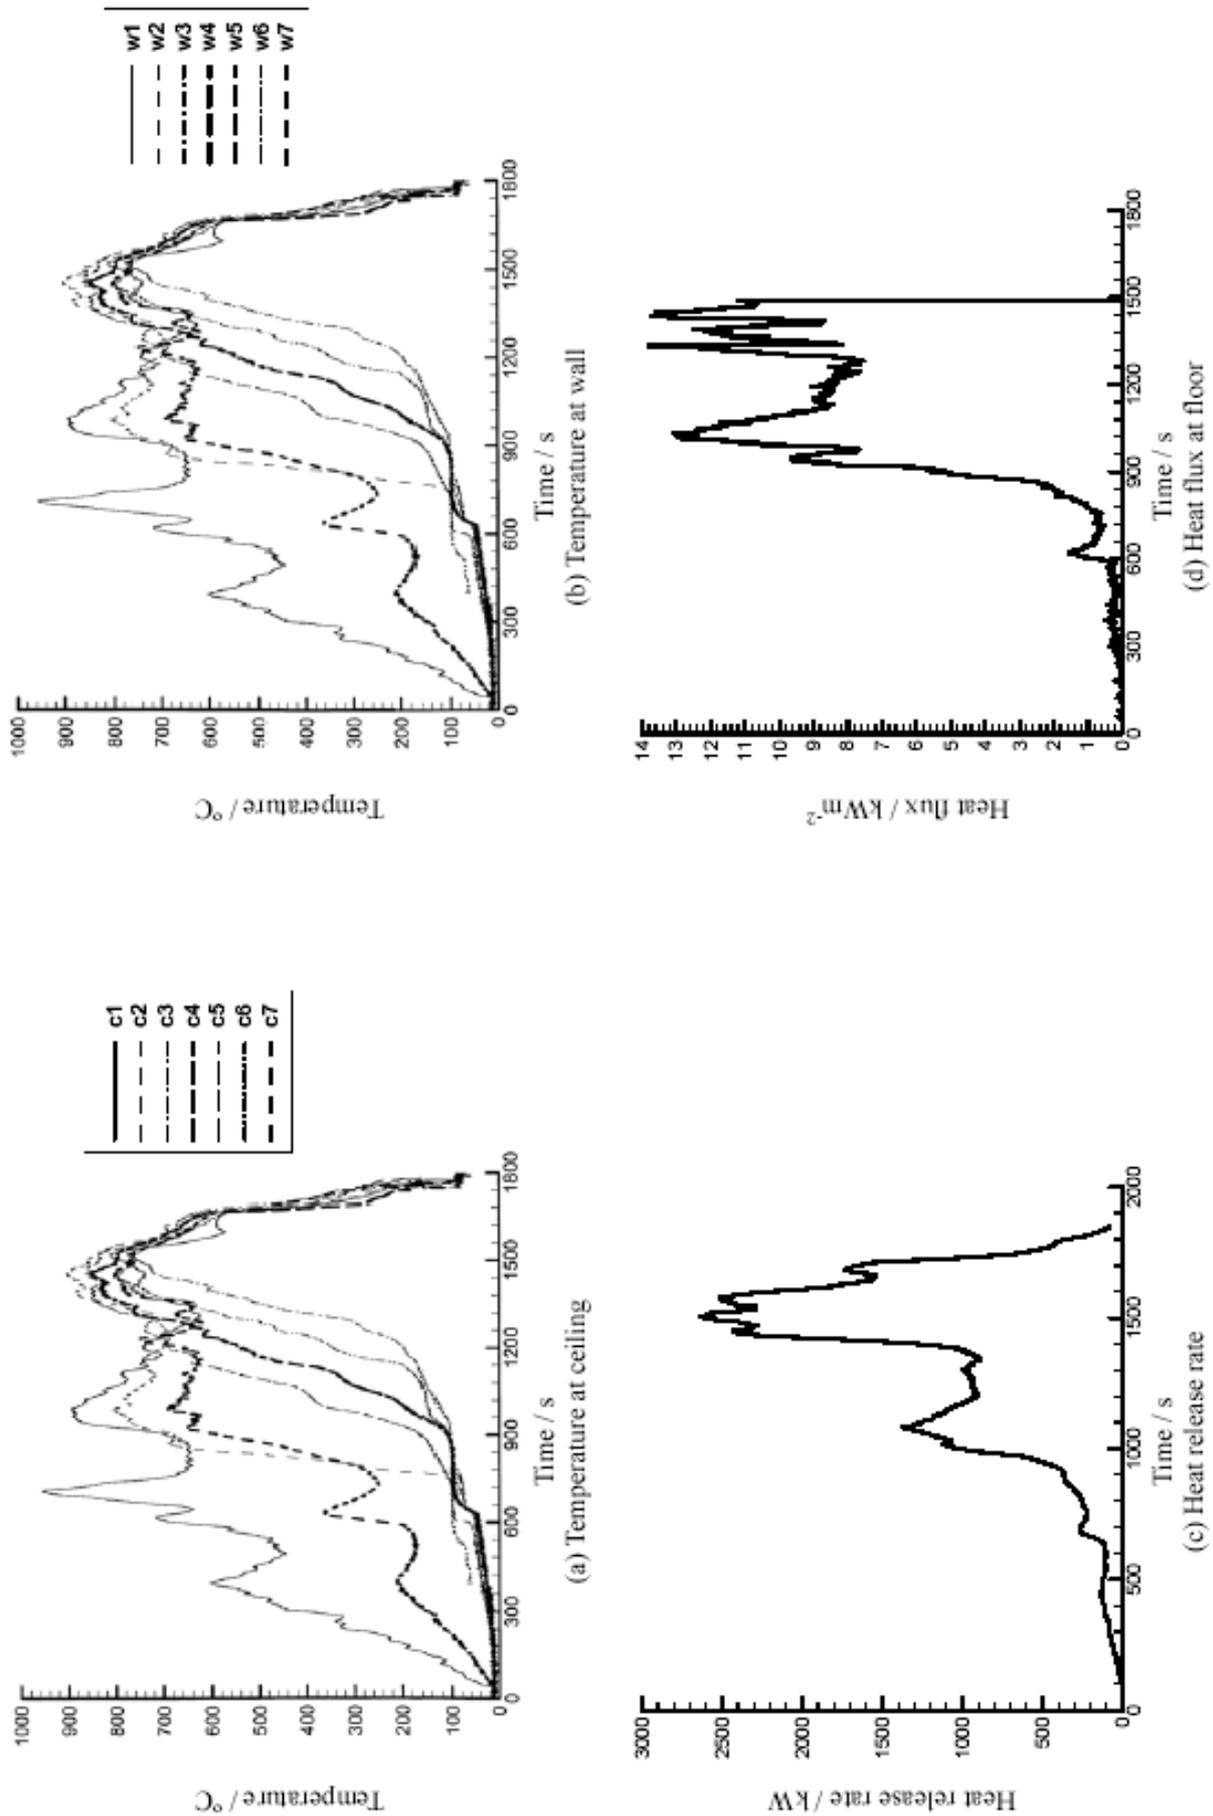
Fig. 11: Testing results for M1g

M1g	8 mm fire retarded chipboard with wallpaper	Ignition of wall material behind burner at 174 s; Tip of flame reached ceiling at 287 s; Ignition of ceiling material above burner at 364 s and flame ceased again; Re-ignition of material at 586 s; Tip of flame reached ceiling at 624 s and then ceased; Only little flame over ceiling was observed at 649 s; Flame spread to ceiling panel 2 at 802 s; Flame emerging the doorway at 879 s; Large fire plume emerging the doorway at 958 s; Fire size reduced at 1059 s; Large fire plume emerging the doorway at 1359 s and falling of ceiling panels; Water mist discharged at 1620 s.

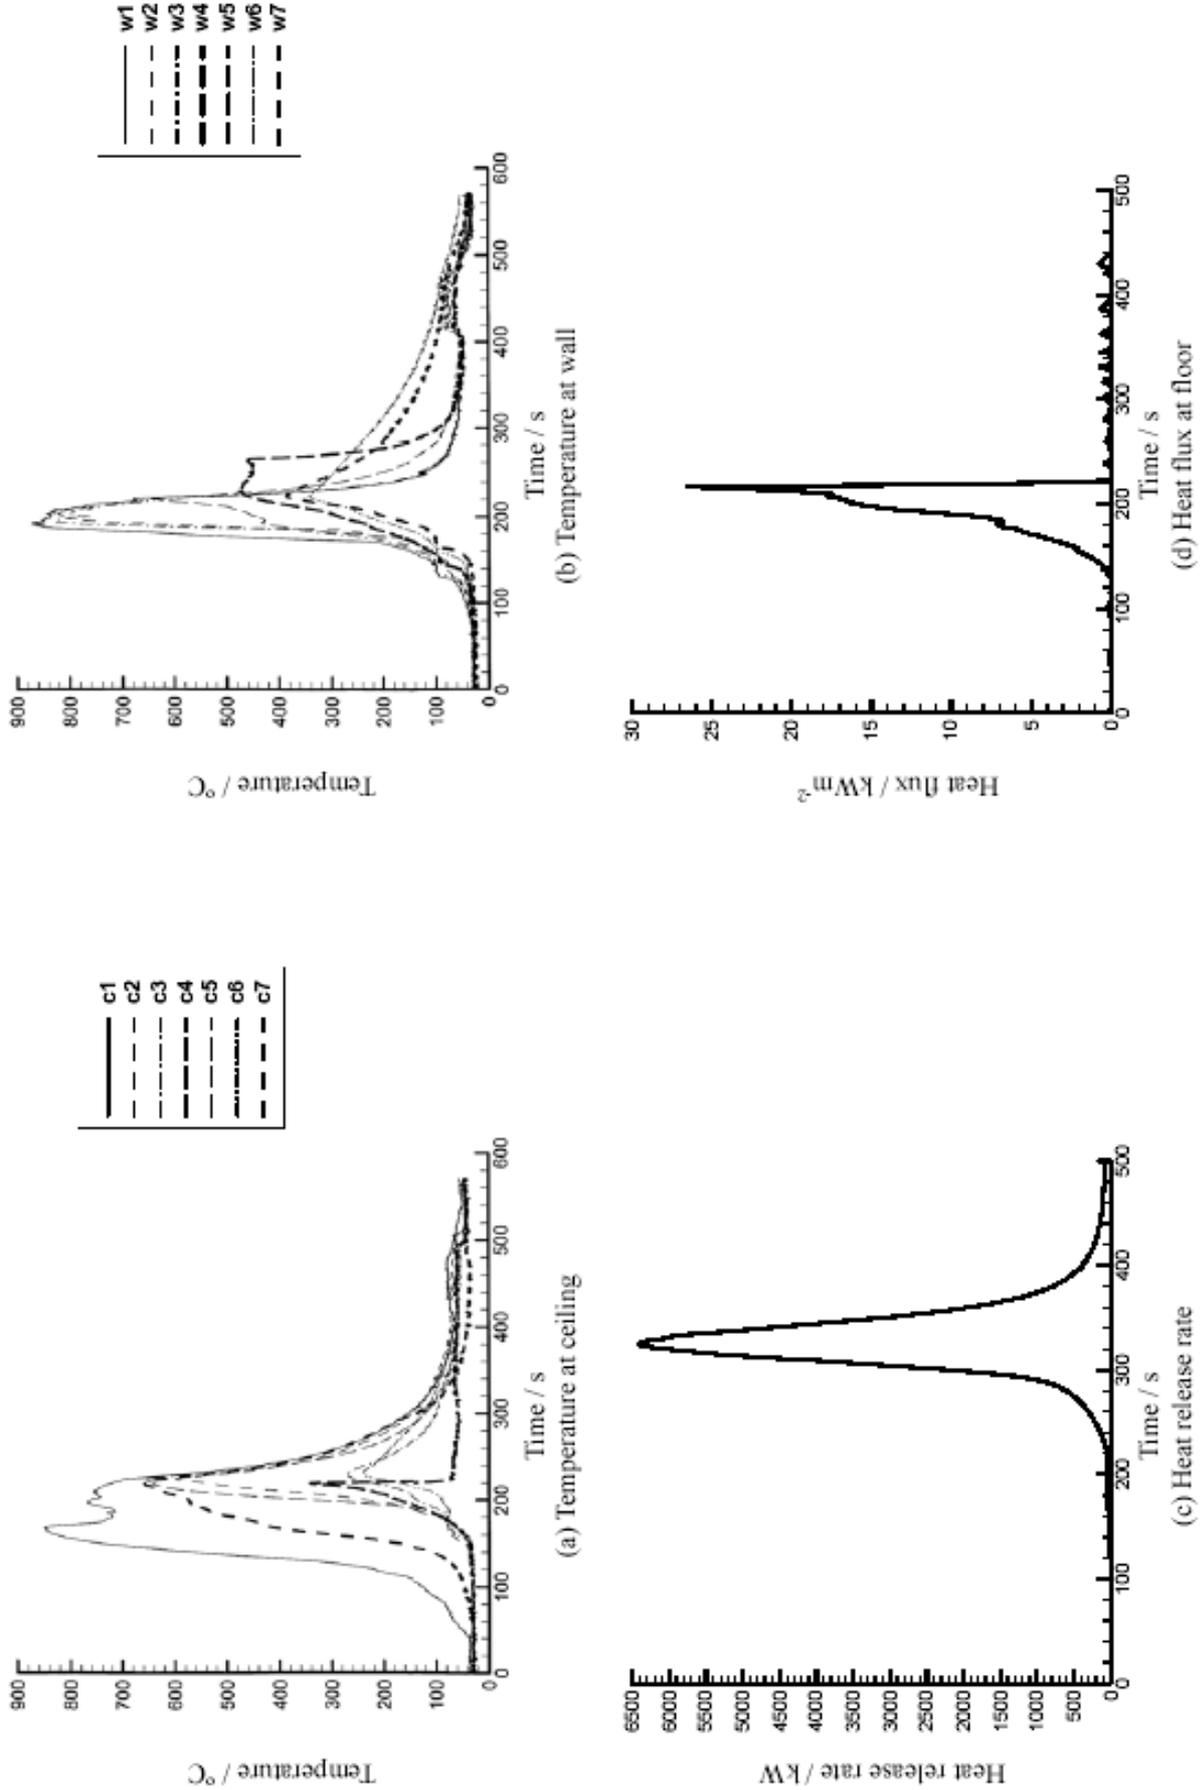
Fig. 12: Testing results for M2a

For the set of M2, in testing the bare chipboard in M2a, fast ignition occurred at 88 s. Flame layer over ceiling was formed at 163 s with flame emerging the doorway at 178 s. A large fire plume came out at 203 s and 1 MW was reached at 291 s. With fire retardant in M2b, ignition occurred at 136 s. Flame layer over ceiling was formed at 294 s and flame emerged at 338 s. The flame over materials ceased at 1016 s.
