# ASSESSMENT OF FIRE BEHAVIOUR OF TIMBER PARTITION MATERIALS WITH A ROOM CALORIMETER

Fire behaviour of timber partition materials were assessed in a room calorimeter with size following ISO 9705. Fourteen full-scale burning tests on timber materials used in the local industry with and without paint, wallpaper, fiberglass and fire retardant were carried out. The heat release rate, surface temperature of materials, upper layer gas temperature, floor heat flux and time to flashover were recorded. Flame spreading over the materials was observed.

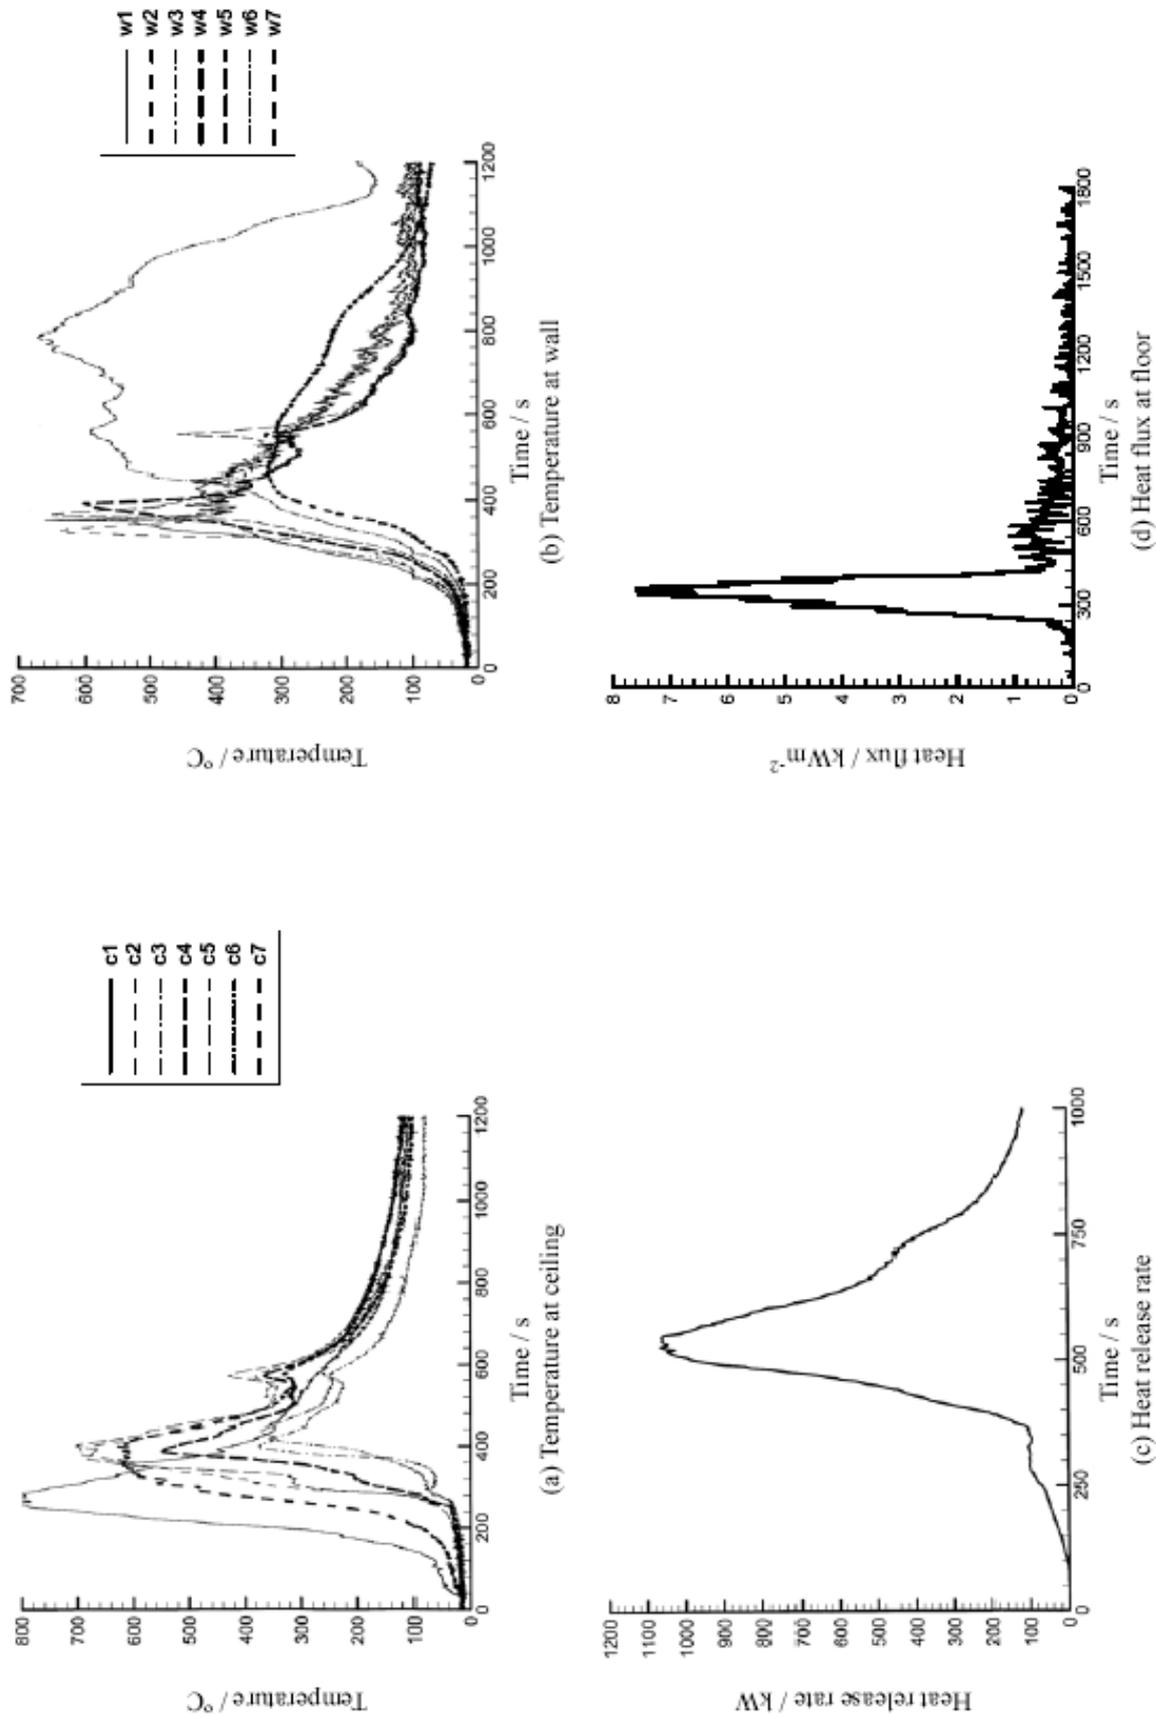
Fig. 13: Testing results for M2b

For the set of M2, in testing the bare chipboard in M2a, fast ignition occurred at 88 s. Flame layer over ceiling was formed at 163 s with flame emerging the doorway at 178 s. A large fire plume came out at 203 s and 1 MW was reached at 291 s. With fire retardant in M2b, ignition occurred at 136 s. Flame layer over ceiling was formed at 294 s and flame emerged at 338 s. The flame over materials ceased at 1016 s.

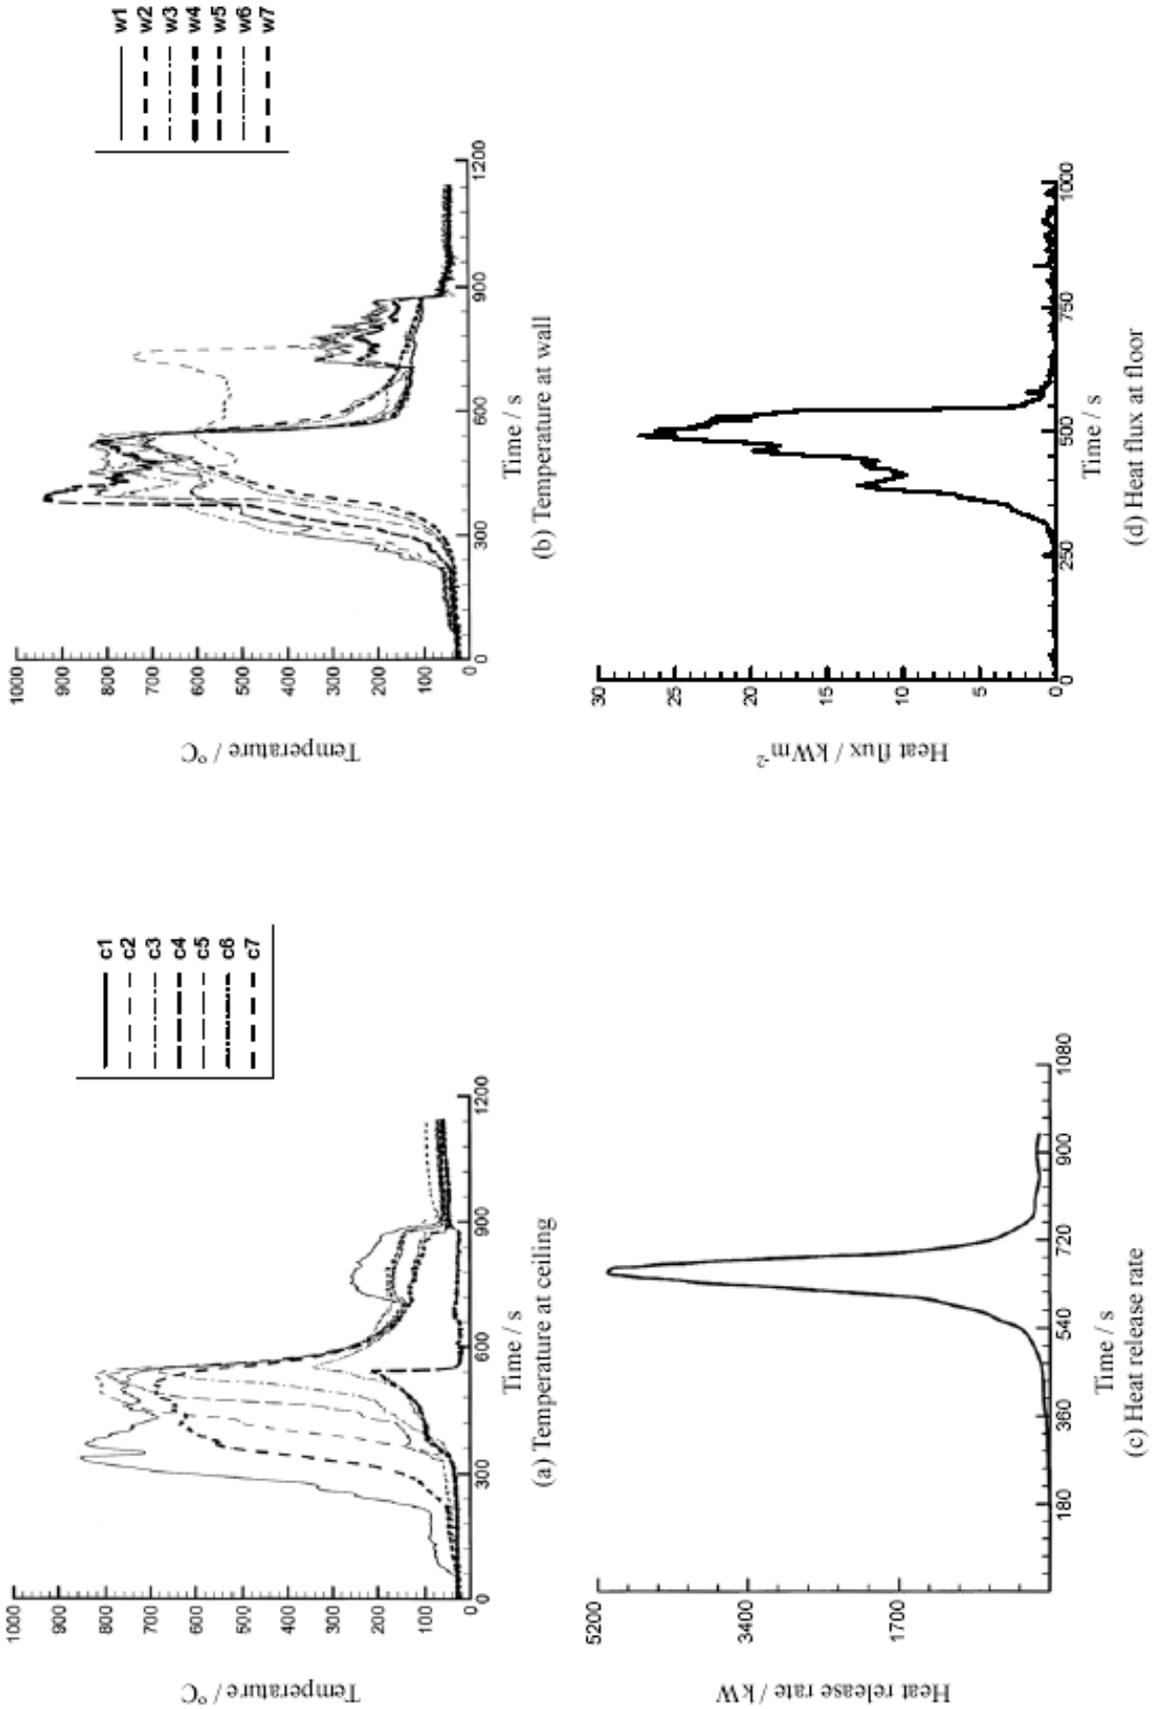
Fig. 14: Testing results for M3a

For M3a, the chipboard was ignited at 207 s. Ceiling flame layer was formed at 384 s and flame emerged at 392 s. Large plume of fire came out at 452 s and heat release rate reached 1 MW at 581 s. When fire retardant was applied in M3b, ignition occurred at 210 s. Ceiling flame layer was formed at 382 s and flame emerged at 530 s. The ceiling panel was burnt out at 610 s and flame over materials extinguished at 835 s. The test was terminated at 20 minutes. Except those wall materials close to the ignition source and the ceiling-wall interface, other parts of the wall materials were not consumed in burning. In M3c, ignition was recorded at 160 s. Flame layer over ceiling was formed at 350 s and flame emerged the

The 4.5 mm chipboard (M3a) was tested with fire retardant (M3b) and with fiberglass backing (M3c). The heat release rate trend in M3c was similar to M1c, both with fiberglass backing. A smaller peak was reached earlier in the test with a peak heat release rate over 1 MW at flashover. However, in M3c, flame spread more rapidly than bare chipboard. This is contradicting to the cases on M1a and M1c. Very limited burning was seen in test M3b. There was only little burning over the left sidewall next to the flaming region of the ignition source and char was formed on the rear wall. The heat release rate was kept below 100 kW and the test was terminated after 20 minutes when there was flame from the ignition source only.

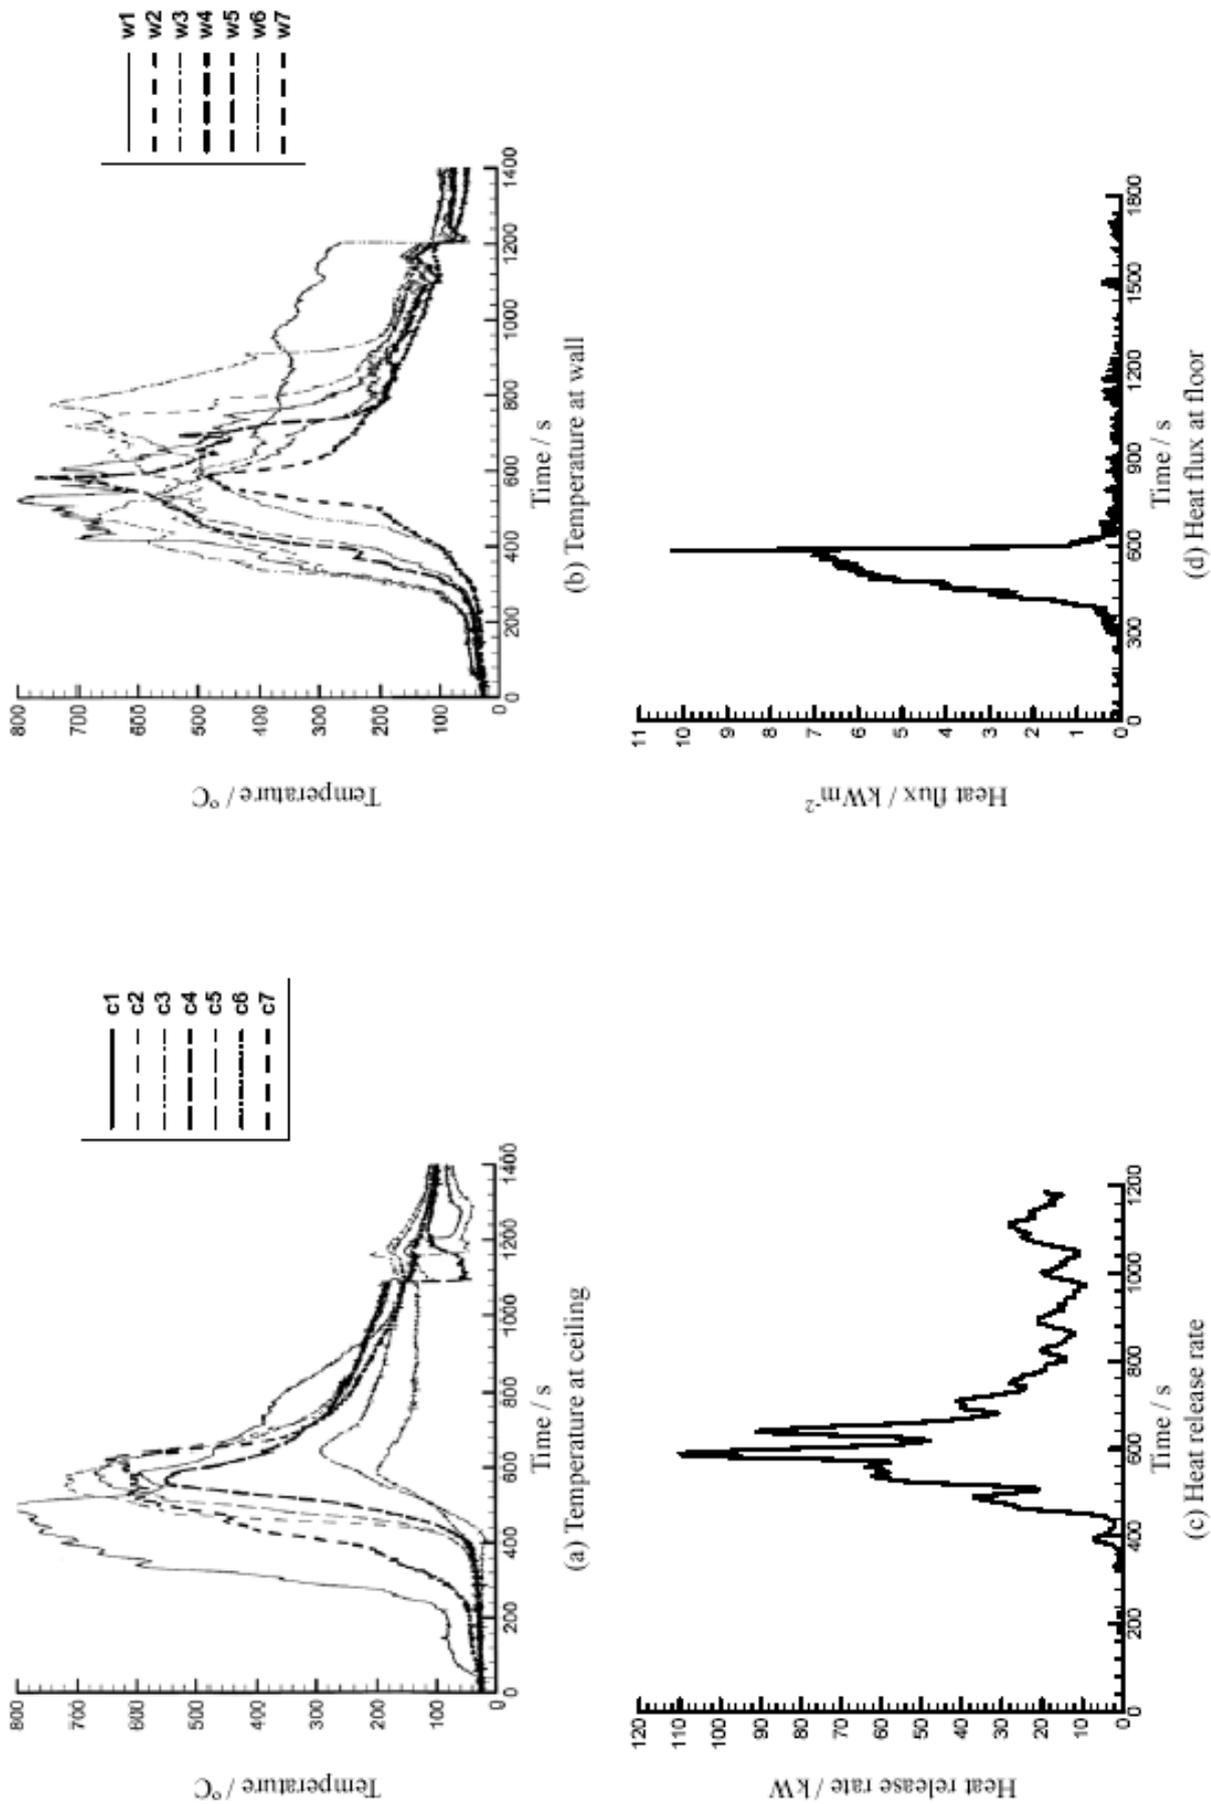
Fig. 15: Testing results for M3b

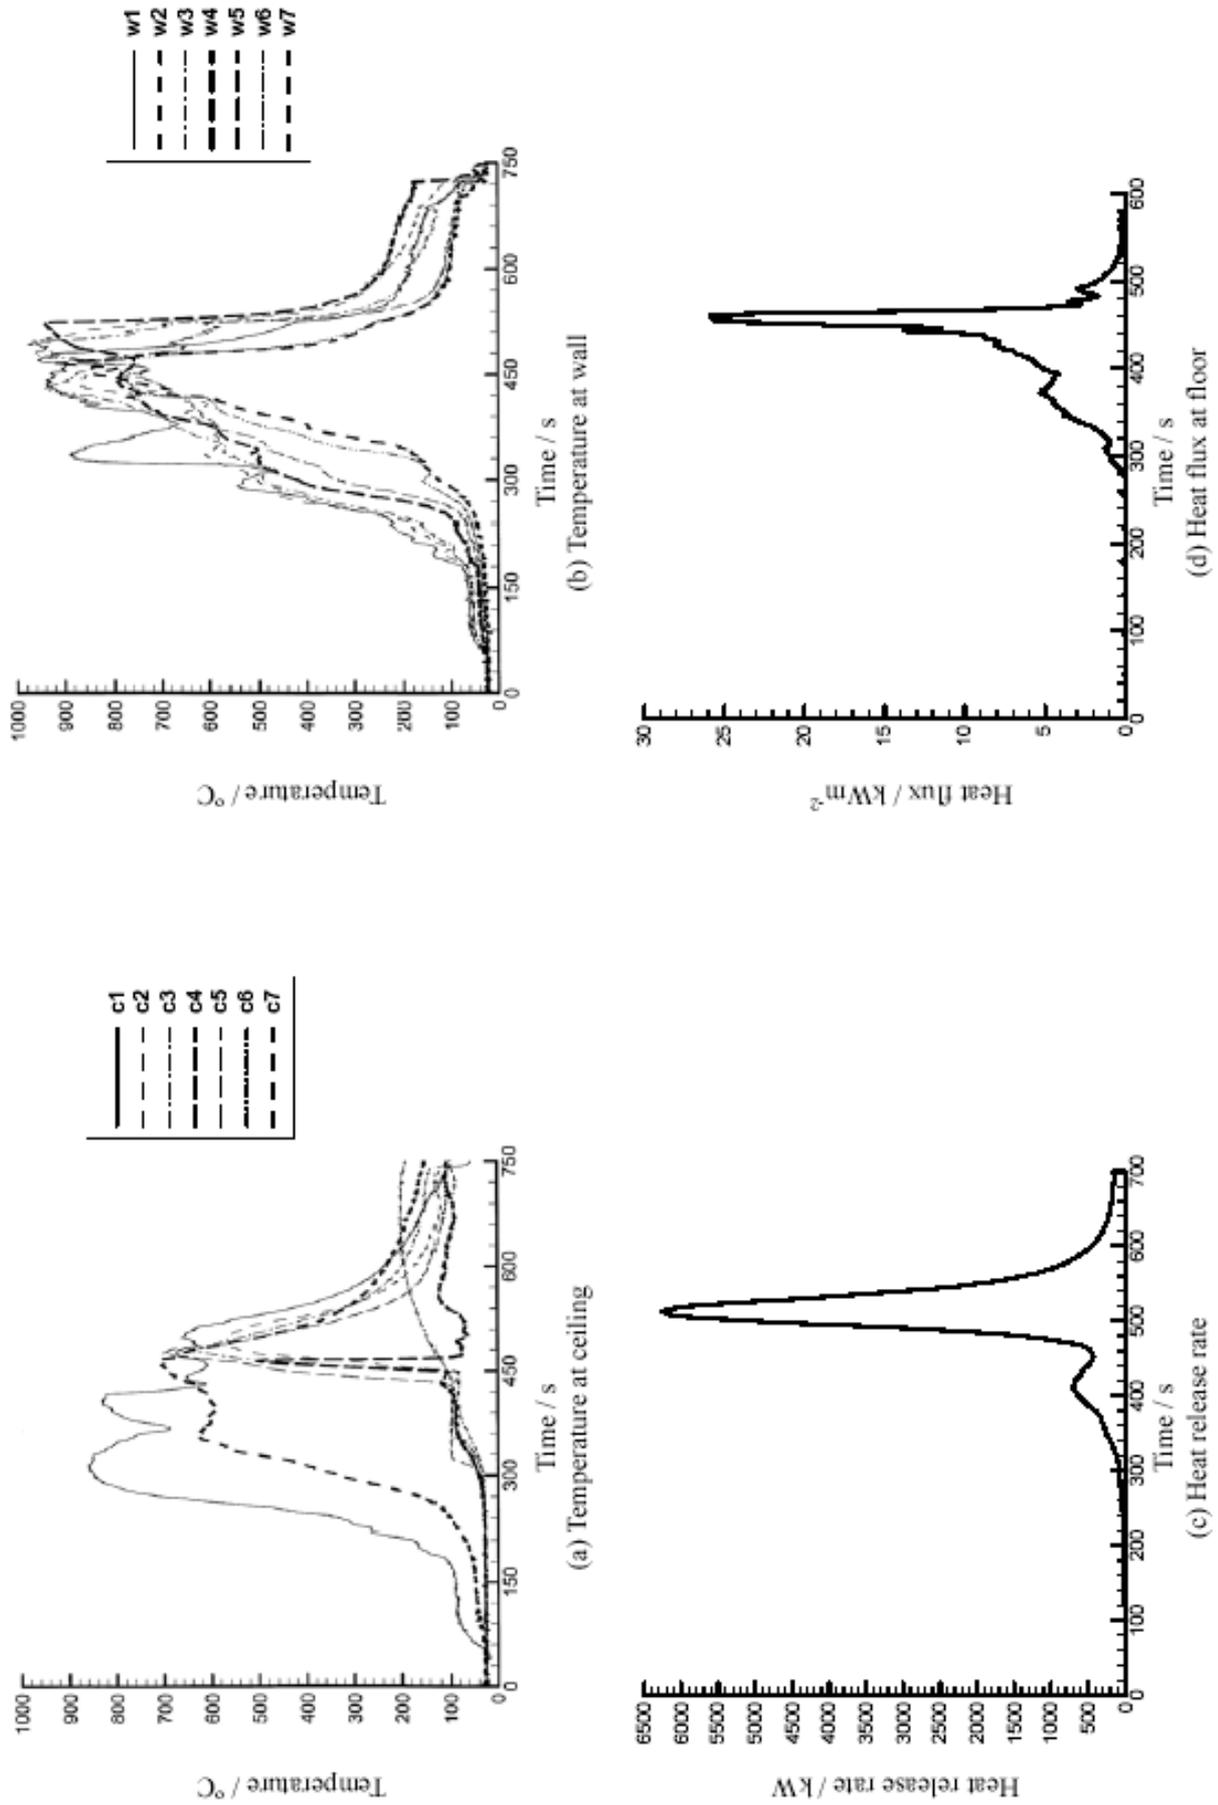
Fig. 16: Testing results for M3c

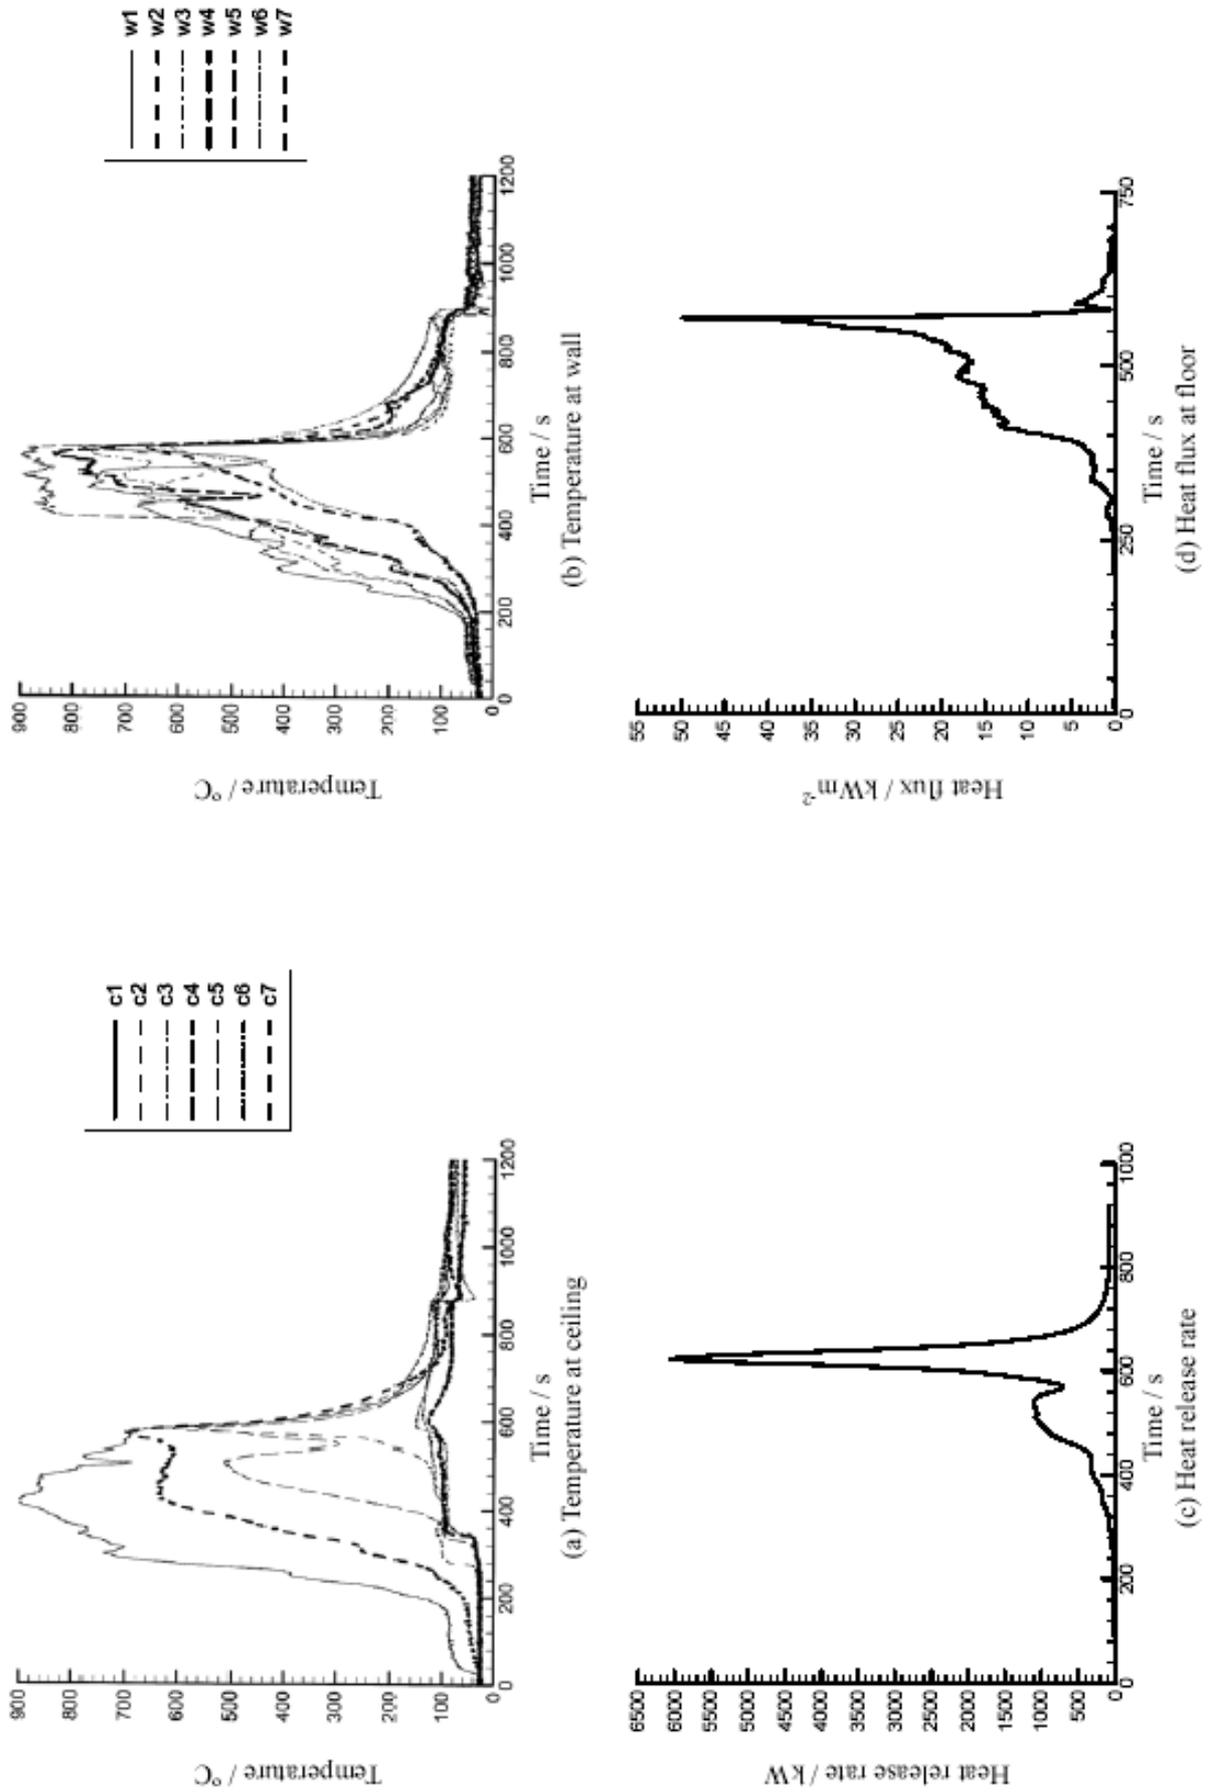
Fig. 17: Testing results for M4a

In M4a, the materials behind the burner were ignited at 155 s. Flame layer formed over the ceiling at 328 s. Flame emerged the doorway at 401 s and a large plume at 435 s. Heat release rate reached 1 MW at 498 s. There was only surface burning over the chipboard and materials were not totally consumed in burning. In M4b, ignition of the wall surfaces was recorded at 215 s. The ceiling above the ignition source was ignited at 405 s. The ceiling panels fell off at 432 s and at 706 s which greatly affected the flame spread. The test was terminated at 20 minutes.

In testing of 11 mm chipboard (M4a) the flame spread phenomenon was observed to be the same as in the testing of M1, M2 and M3. Upon ignition of wall behind the ignition source, flame spread upward over the interface of the rear wall and left sidewall. When the flame tip reached the ceiling, flame spread along the wall-ceiling jet region and laterally along the interface between the sidewalls and the ceiling. When it was close to flashover, flame spread downward from the wall-ceiling interface and a limited lateral flame spread from the interface of the left sidewall and rear wall, and flaming region of the ignition source were observed. Prior to flashover, all materials were ignited and the room was filled with fire. With the application of fire retardant (M4b) longer time was taken for the ignition of the material behind the ignition source. Char was formed on the surface above the ignition source after a period of limited burning. The heat release rate was limited to be less than 200 kW. There was no further burning over the surface of materials and the test was terminated at 20 minutes. The fire retardant was very effective in reducing flame spread over wood surfaces.

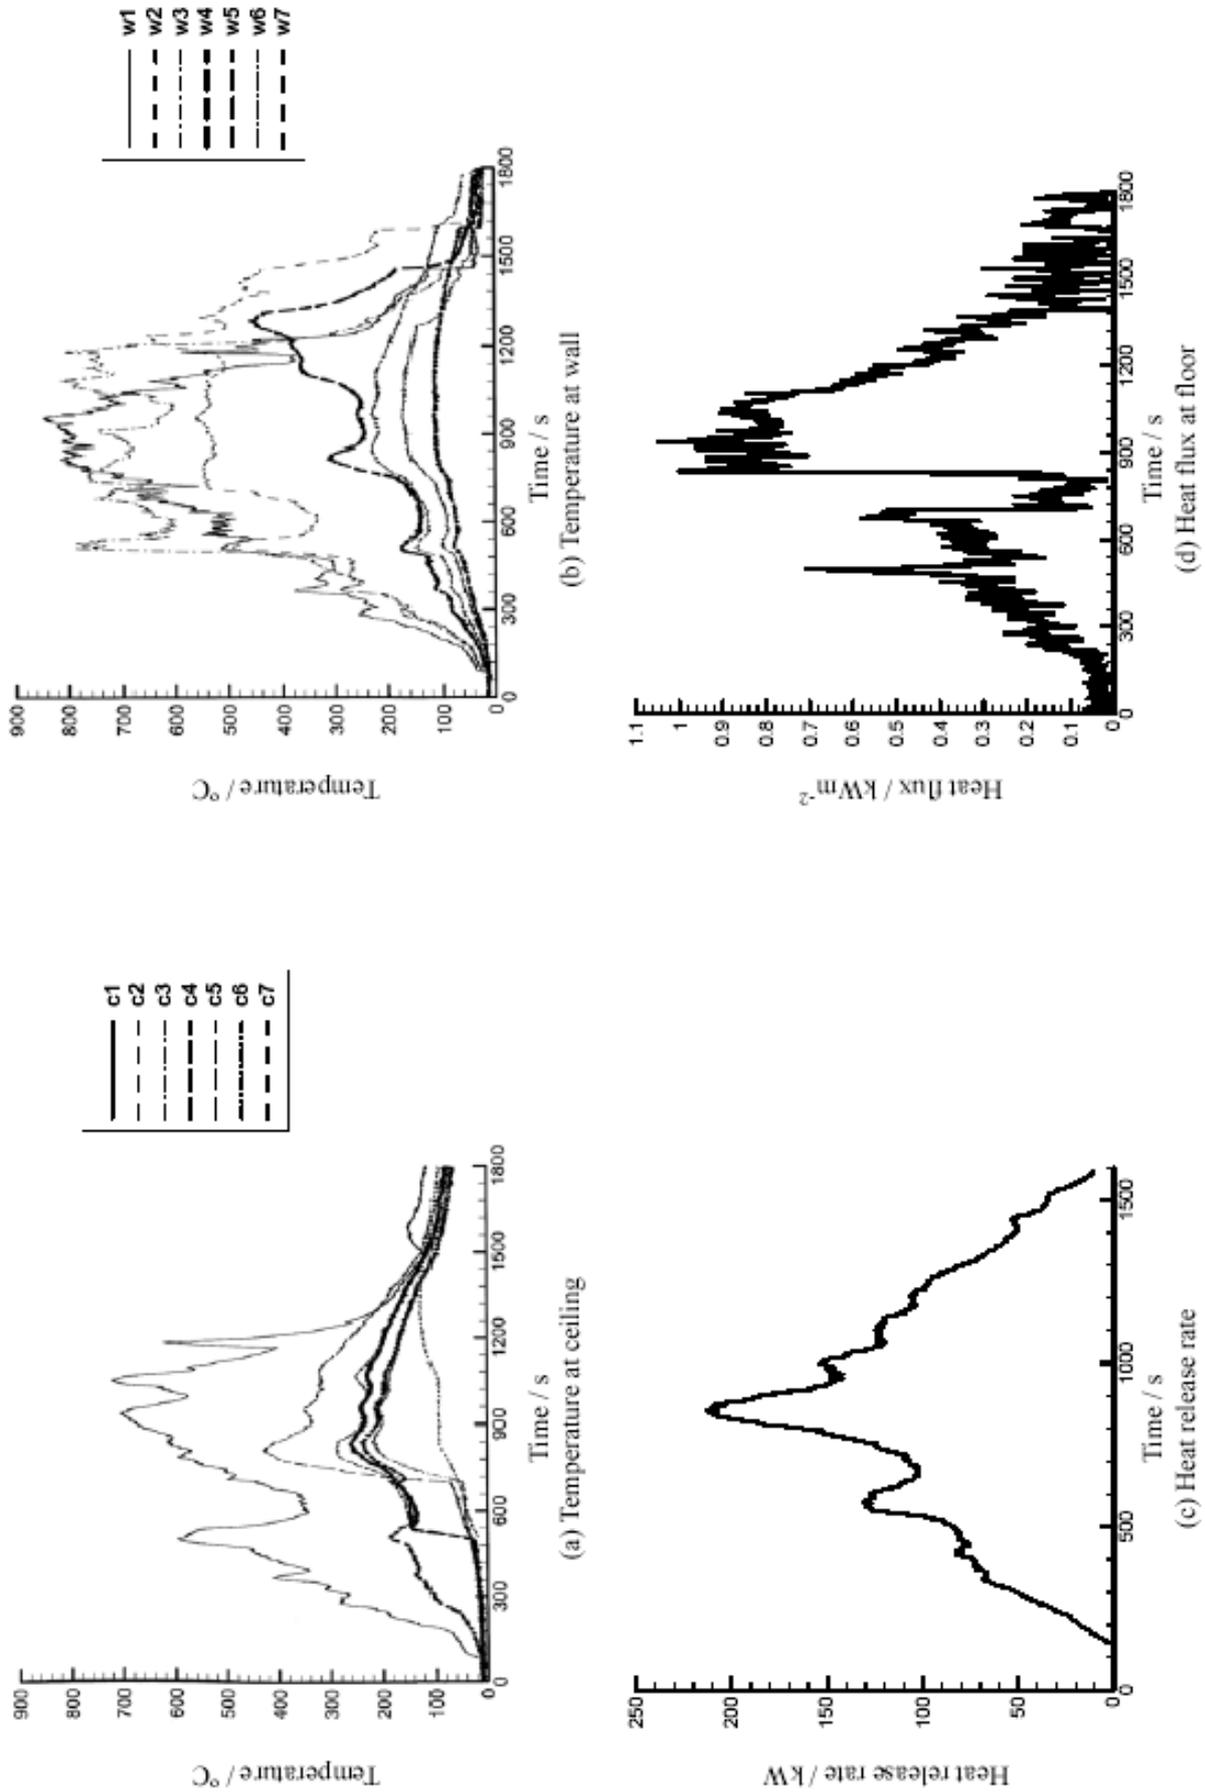
Fig. 18: Testing results for M4b
