EXPERIMENTAL MEASUREMENT ON AIR TEMPERATURE IN A GLASS FAÇADE FIRE

ABSTRACT

There are concerns on the behaviour of glass façade under a big fire. Preliminary real-scale experiments on a single skin façade were carried out at a big laboratory in Southern China. Burning behaviour of a three-storey high single skin glass façade with double glazing due to an adjacent fire was studied. A glass pane of the façade was taken out with a model fire chamber placed next to the opening. Flashover in the chamber was set up with flame spreading out to act at the glazing system. Air temperature outside the glazing above the fire chamber was measured and reported in this paper.

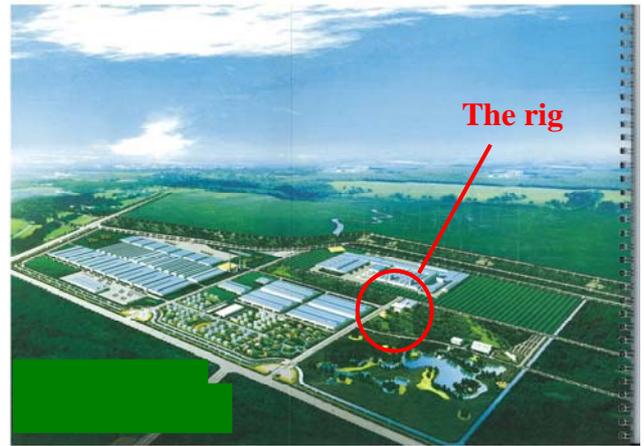
(b) The site

Fig. 1: The rig

A long-term real-scale burning testing programme was worked out [e.g. 2]. Part of a glass façade after testing wind action and water penetration was burnt. The rig was located at a big aluminum manufacturing plant in Southern China as shown in Fig. 1a and b. Results deduced at the first stage of study on the measured air temperature next to the external façade surface will be reported in this paper.

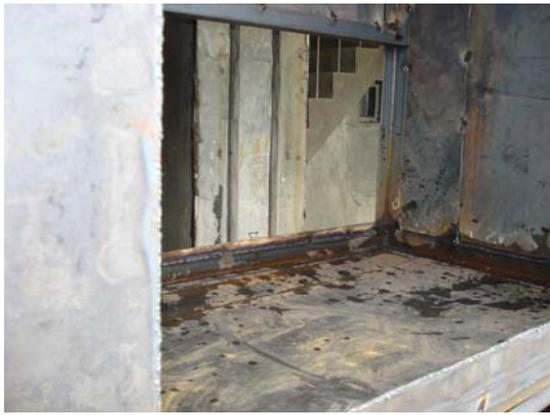
(a) Top view

Fig. 4: The pool fire

The fire chamber is made of steel with size 1.4 m by 0.7 m by 2 m as shown in Fig. 3. There is a door of size 0.8 m by 2 m at the front for directing flame spreading out. A rectangular gasoline pool fire of size 1.4 m by 0.7 m and depth 0.1 m as shown in Fig. 4 was set up in the chamber at 0.9 m above the floor as shown in Figs. 3 and 4. A rear opening of size 1.4 m by 0.5 m was constructed as shown in Fig. 3 for supplying fresh air to sustain combustion.
