Lessons Learnt from the Great Kaohsiung Gas Explosions and Disaster Management for Tsing Yi Island with Fuel Tanks

W.K. Chow JP FHKEng and Edgar C.L. Pang

Research Centre for Fire Engineering, Department of Building Services Engineering

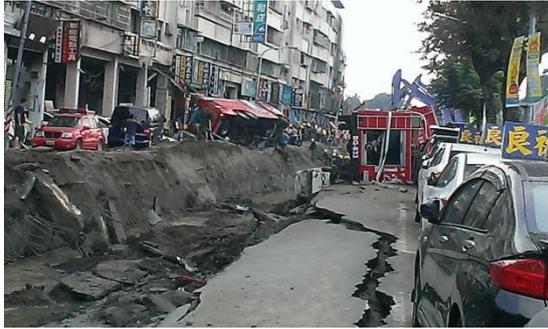
(a) Road surface collapsed

Fig. 1: Damages caused by the Kaohsiung gas explosions (Photos taken by Su 2014)

Multiple gas explosions occurred in Kaohsiung, Taiwan about midnight on 31 July 2014 and early on 1 August 2014 [1-10]. The flame height was observed to be over 15 storeys in height. Miles of roads surface was broken and adjacent buildings were seriously damaged [11] as shown in Fig. 1. More than 300 persons were killed, lost or injured.

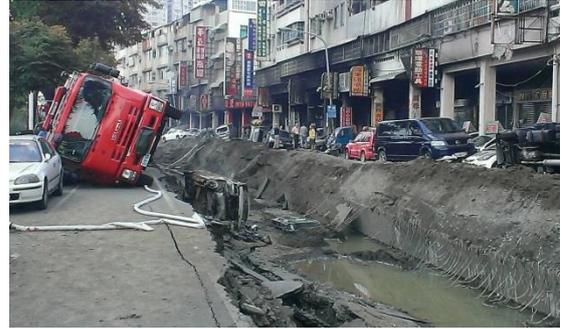
(b) Fire engine overturned
